TREE RESOURCE ANALYSIS & ARBORIST REPORT - THE SANTA CRUZ CITY SCHOOLS WORKFORCE HOUSING PROJECT – 313 SWIFT STREET, CALIFORNIA

Site visit by:
Nigel Belton – ISA Certified Arborist WE-0410A
May 24, 2023

Job – Santa Cruz City Schools – 6.19.23

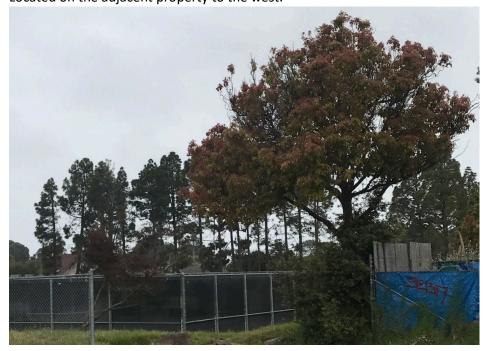
<u>Tree #21 – 17-inch DBH Camphor Tree (Cinnamomum camphora):</u>

Located on the adjacent property to the west.

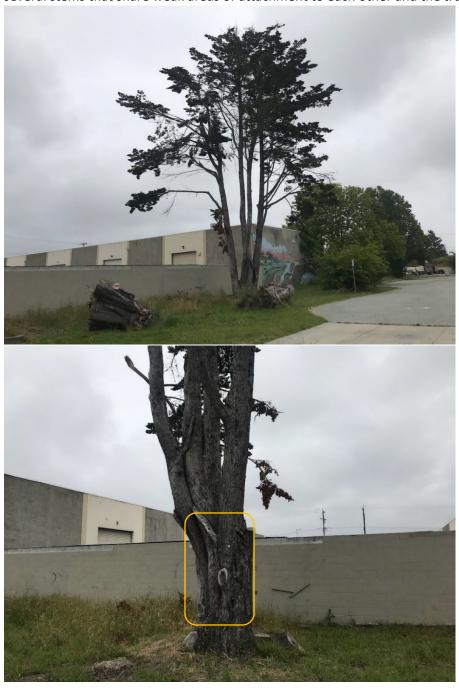
<u>Tree #15 – 56.5-inch DBH Monterey Cypress:</u>

I determined that one Heritage Tree is unsuitable for preservation, because of its poor structural condition rating (Tree #15).

I observed a dieback pattern in the canopy caused by Seiridium Canker infections. I also observed large broken branches in the crown of this tree. The tree has a poor codominant growth pattern, having several stems that share weak areas of attachment to each other and the trunk.

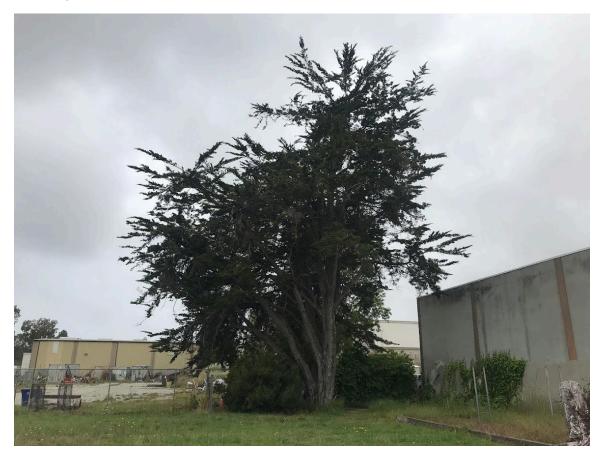
<u>Tree #16 – Monterey Cypress (62-inch diameter trunk at 12-inches above ground):</u>

This tree is located within the footprint of the proposed parking area next to the north property boundary.

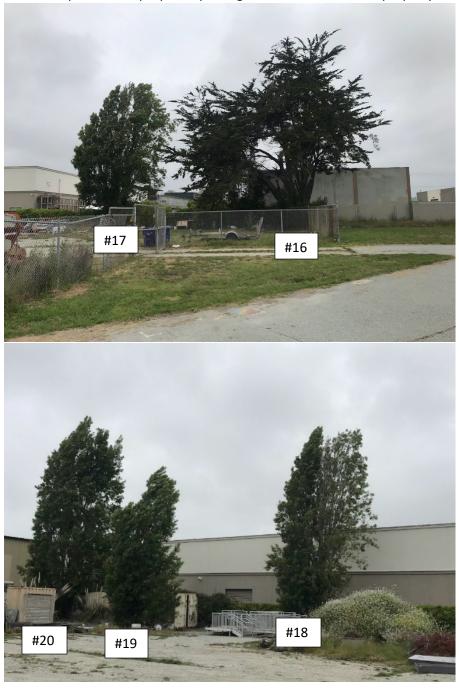
<u>Tree #20 – 14 & 16-inch DBH Lombardy Poplar:</u>

Note that the trunks of both trees were hidden by Ivy growth. These trees are located in close proximity to the footprint of the proposed parking area next to the north property boundary.

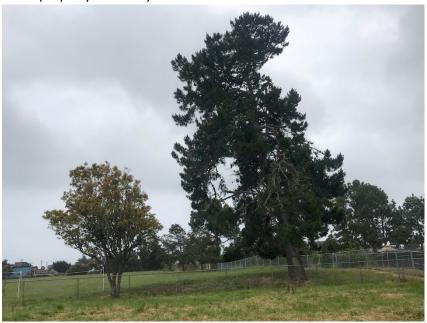
Tree #23 – 44-inch DBH Monterey Pine (Pinus radiata):

This tree is adjacent to the footprint of the proposed driveway and turnaround area adjacent to the south property boundary.

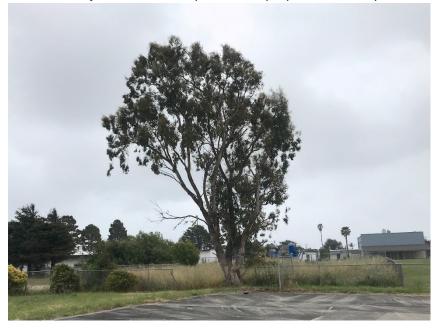
<u>Tree #25 – Silver Dollar Eucalyptus (Eucalyptus polyanthemos) - 28.5-inch trunk diameter at 30-inches above ground:</u>

This tree is adjacent to the footprint of the proposed driveway on the south side of the property.
