ARBORIST REPORT-

Tree Resource Evaluation & Project Impact Analysis

Peace Church 900 High Street Santa Cruz, CA APN:001-022-40 September 25, 2022

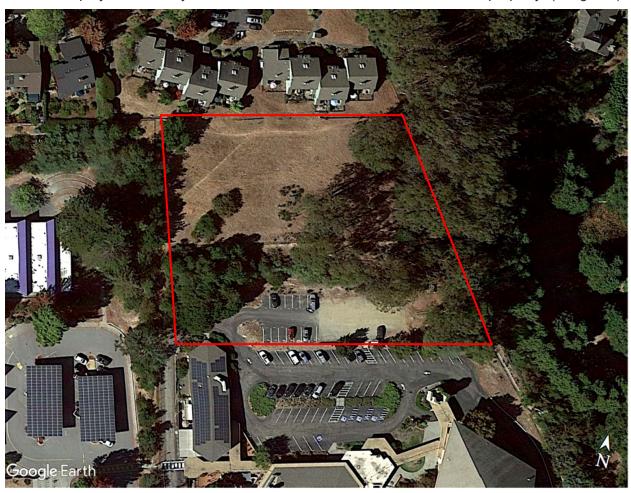
Image #1 - Proposed apartment complex site. Project boundary in red outline.

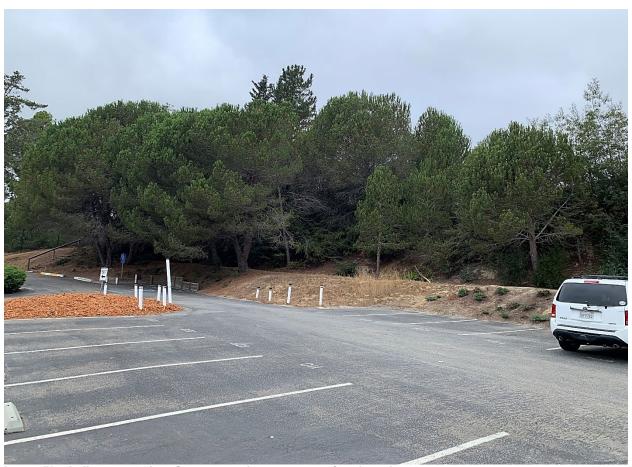
Image #2 – Italian stone pine. Grow at southwest corner of project site.

Most stone pine are mature or semi-mature trees. Some young stone pine grow on the slope behind the mature pines.

The pines are in good or fair condition.

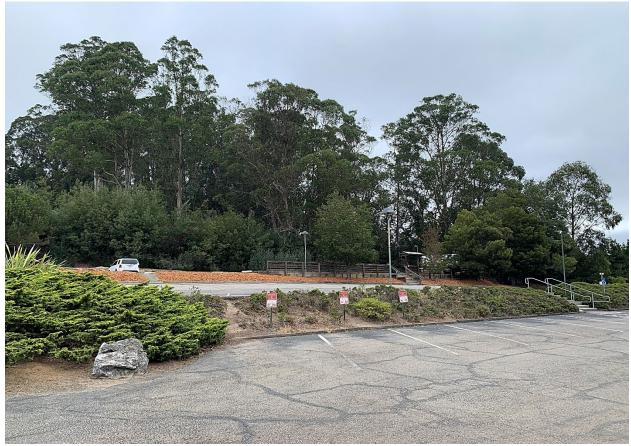
Image #3 - Blue gum eucalyptus, taller backgound trees, growing along the east perimeter of the parcel.

The blue gum species make up the largest group of *Heritage Trees*. Many have structural defects including co-dominant trunks with included bark², trunk leans, unbalanced canopies, and over extended limbs.

Of the defects listed, overextended limbs are the defect most likley to result in failure. Overextended limbs grow beyond the main canopy and may have poor taper relative to their length. Such limbs are more likely to fail due to excessive mechanical stress on the limb.

Two-thirds of the blue gums are in fair condition, with one-third in poor condition.

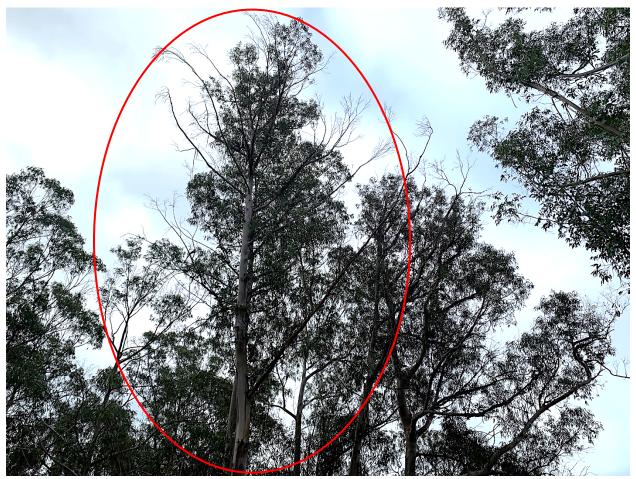
Image #4 - Blue gum eucalyptus in poor condition, (circled). Note tip dieback on limbs.

Tip dieback in eucalyptus may be caused by root disease. Soil borne fungi such as *phytophthora spp.*, are know to cause tip and branch dieback in the eucalyptus species. Tip dieback can also occur due to water deficit.

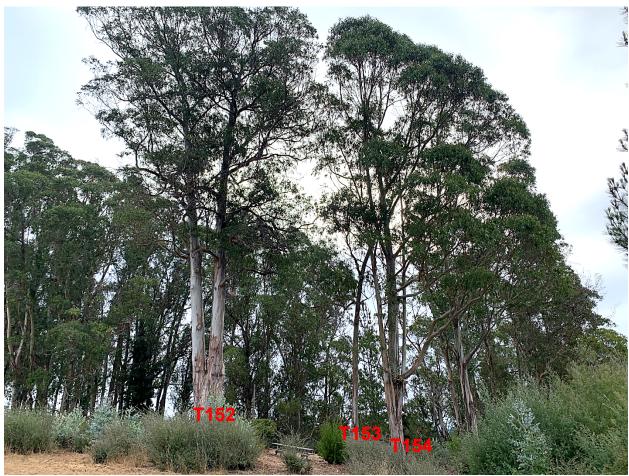
Image #5 - Tree T152, T153 & T154, blue gum eucalyptus. The trees grow on the upper terrace.

Blue gums T152 and T154 are in fair condition. Tree T153 has a trunk bow, limited branch structure, and is in poor condition.

Mitigation will be necessary for grading, excavation and construction of the residential building foundation and raised flow through planter, within the critical root zone of *Heritage* blue gum eucalyptus, T152, T154 and T155.

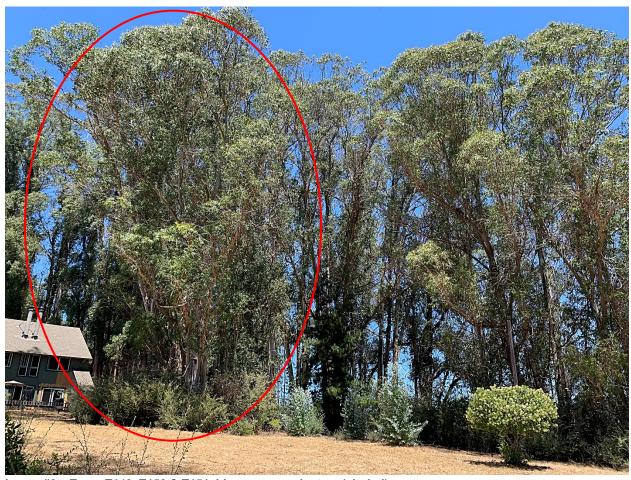
Image #6 - Trees T149, T150 & T151, blue gum eucalyptus, (circled).

Blue gums T149 – T151, grow in the northeast corner of the parcel, and are in fair condition.

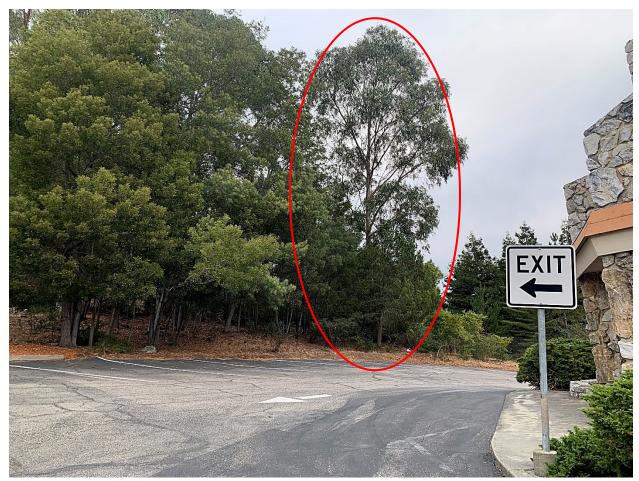
Image #7 – Blackwood acacia growing in southeast corner of project. Tree T133, blue gum eucalyptus, (circled), grows at the southeast corner of the project limits.

One of the blackwood acacia is heritage size and it is in poor condion. Most of the non-heritage acaias are in poor condtion.

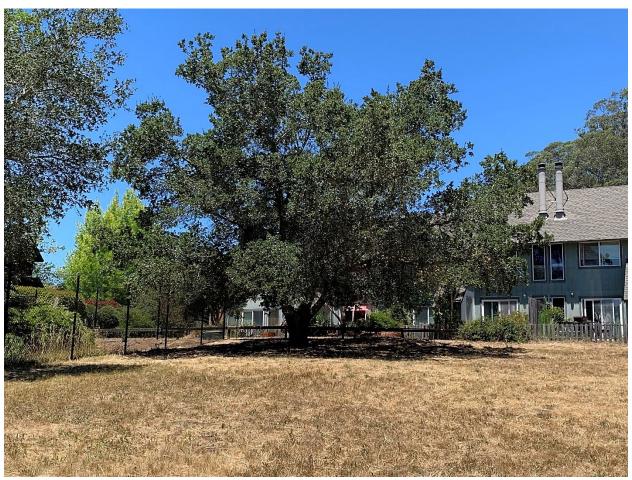
Image #8 - Tree T166, coast live oak, grows in northwest corner of project limits.

Limbs are well attached and the oak is in good condition.
