***ARBORIST REPORT-***  
**Tree Survey & Construction Impact Assessment**

**109 Stanford Ave. - 917,919, & 923 Water Street**

**Santa Cruz, CA**

**9/14/2022**

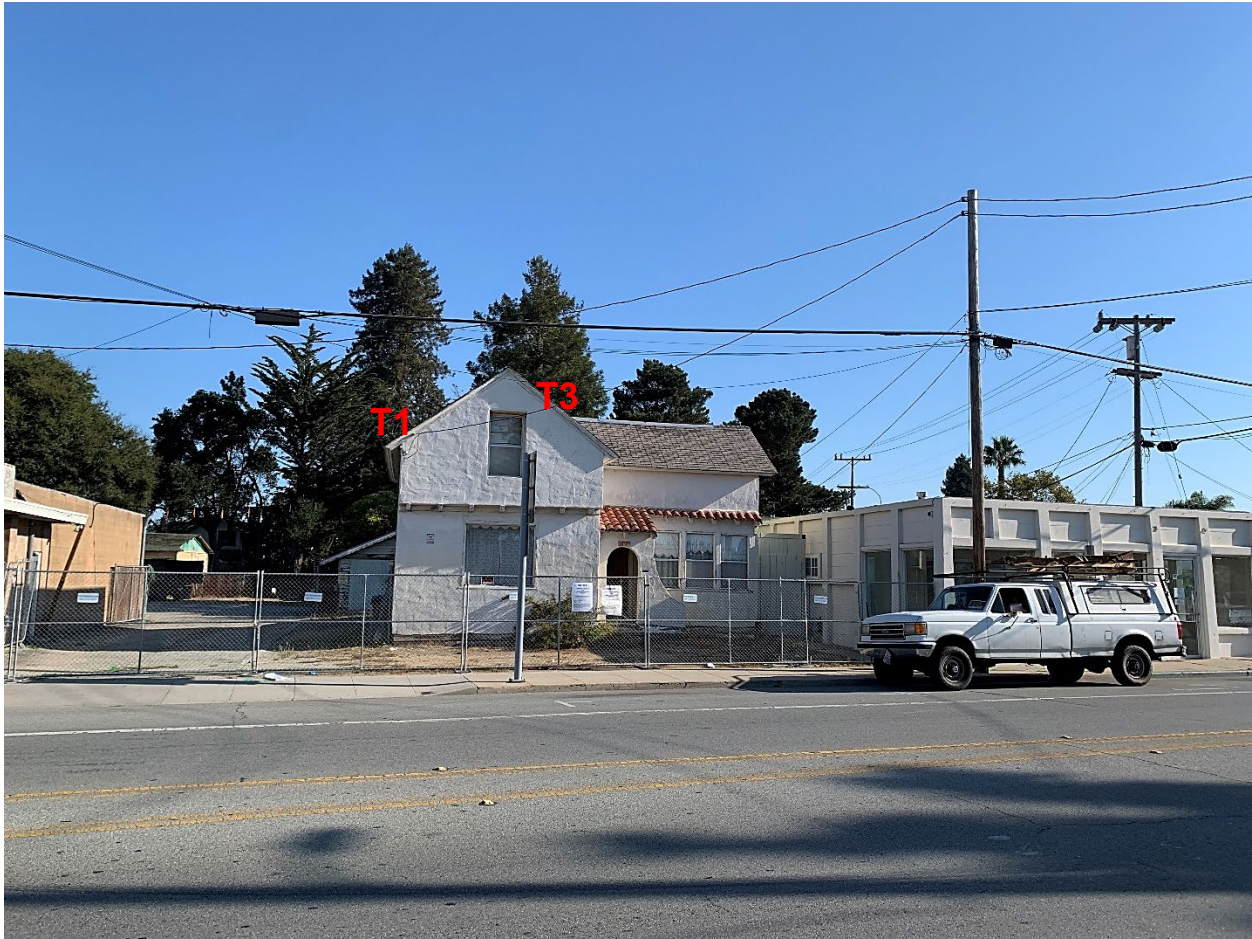
**Image #1 – The three parcels with commercial building on left, home in center and commercial building on right. View from Water Street. The parcel with commercial building on right is on the corner of Water Street & Stanford Avenue. Trees T1, coast redwood and T3 Monterey pine can be seen in background.**

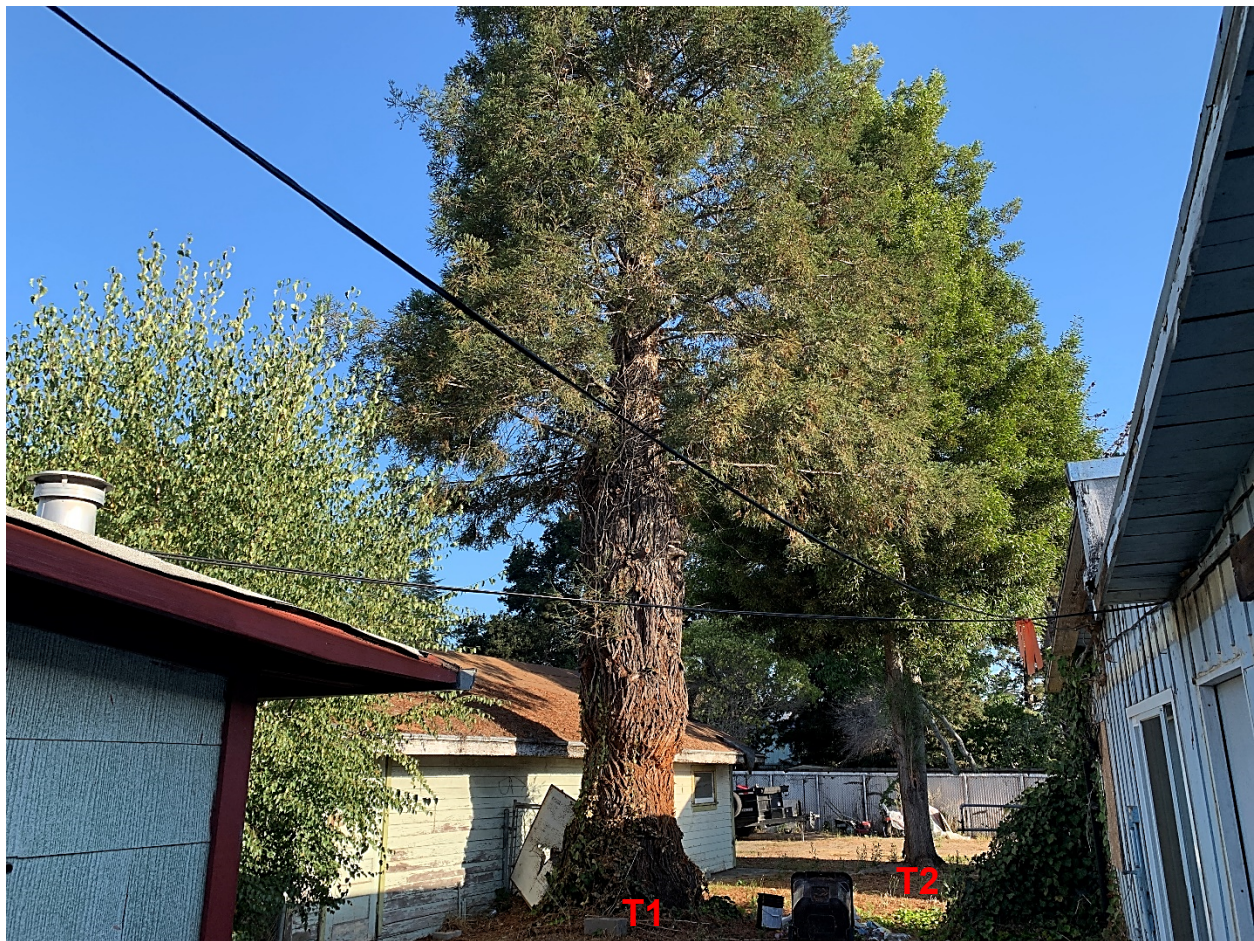
Image #2 – Trees T1, coast redwood & T2 blackwood acacia.

The coast redwood is 46" in diameter and shows water deficit symptoms including a thin canopy density. The trunk swells at 5' to 15' above grade. A fungal conk is visible at 15' above grade. Trunk swelling and conk are indicators of an internal or subsurface issue. The redwood is in fair condition.

The 16" acacia has co-dominant trunks with included bark at 3' above grade. Bark is missing from the trunk base possibly due to mechanical trauma. Several shallow surface roots are damaged as they have no protective bark. The acacia is in fair condition.

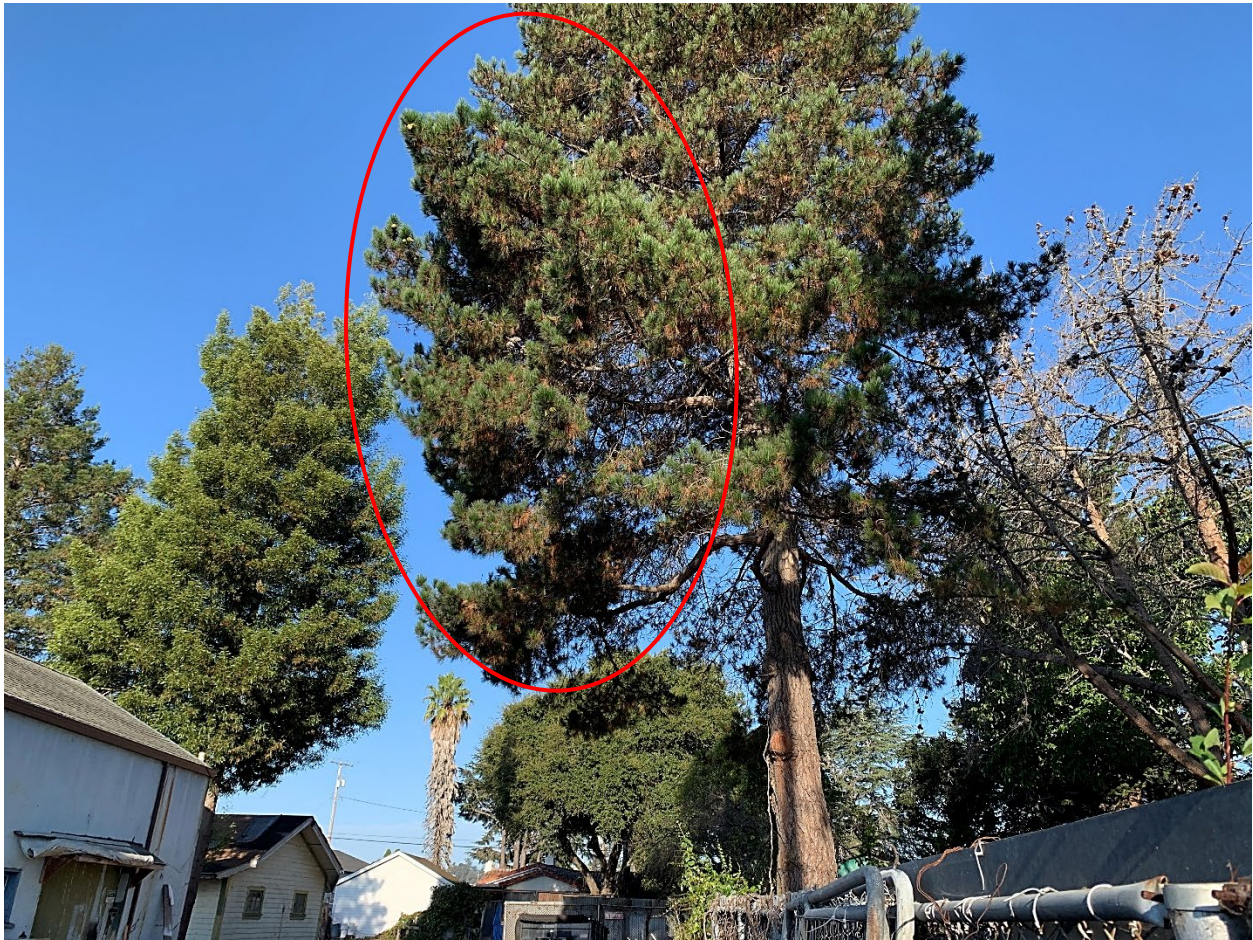
**Image #3 – Tree T3, Monterey pine. Applicants' property is left of tree and fence line. The neighboring pine grows near the property line, and half of its canopy overhangs the project site, (circled).**

The pine grows near the property line and roughly half of the canopy overhangs the project site.

The pine has water deficit symptoms including a thin canopy density. The trunk has a 10 degree lean to the west. There is a minor infestation of Sequoia pitch moth. The pine is in fair condition.

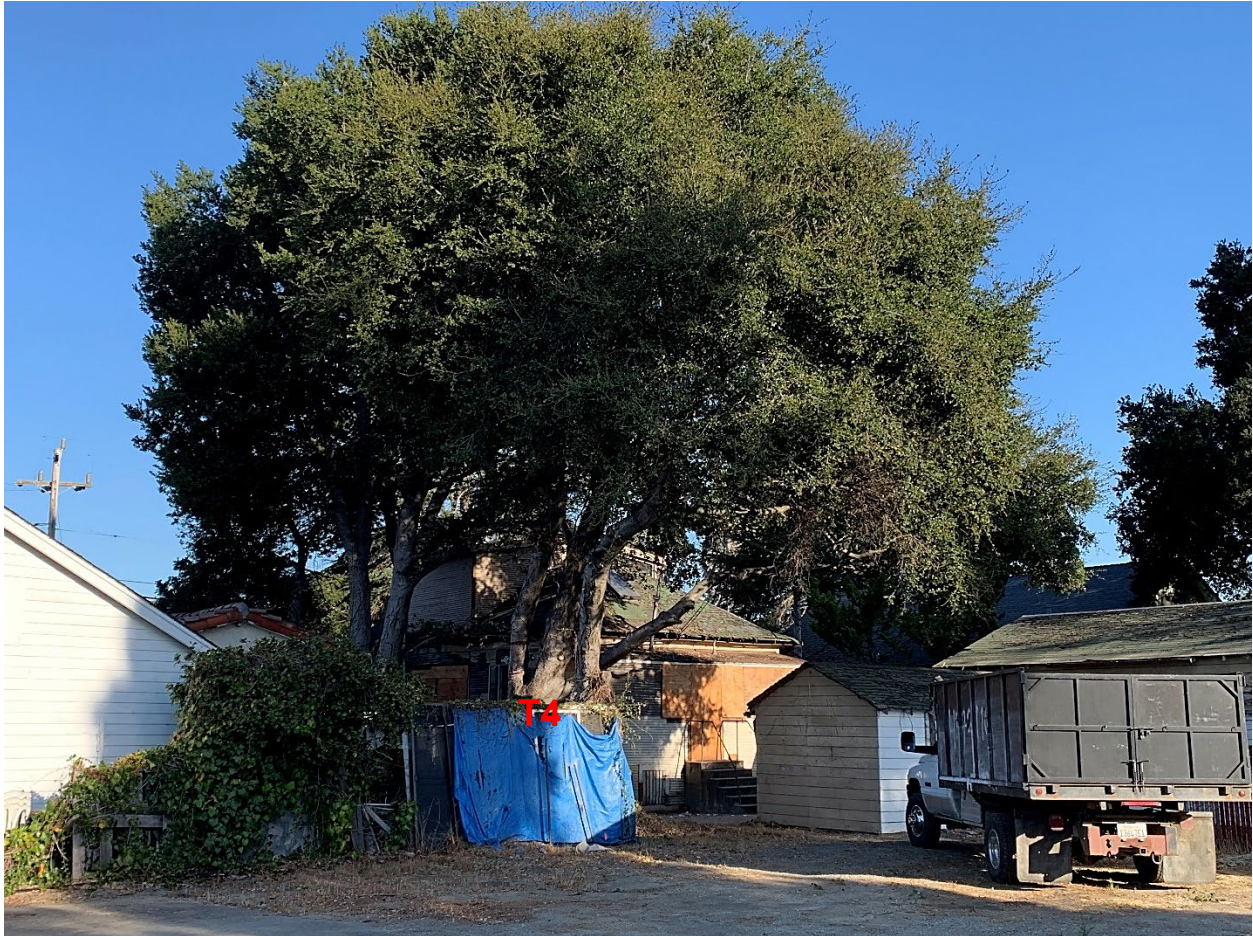
**Image #4 – Tree T4, coast live oak.**

The oak is about 15-feet from the applicant's west property line, and a portion of its canopy overhangs the project site.

The main trunk has a 15 degree lean to the east. At 5' above grade it separates into two co-dominant trunks, (Image #5).

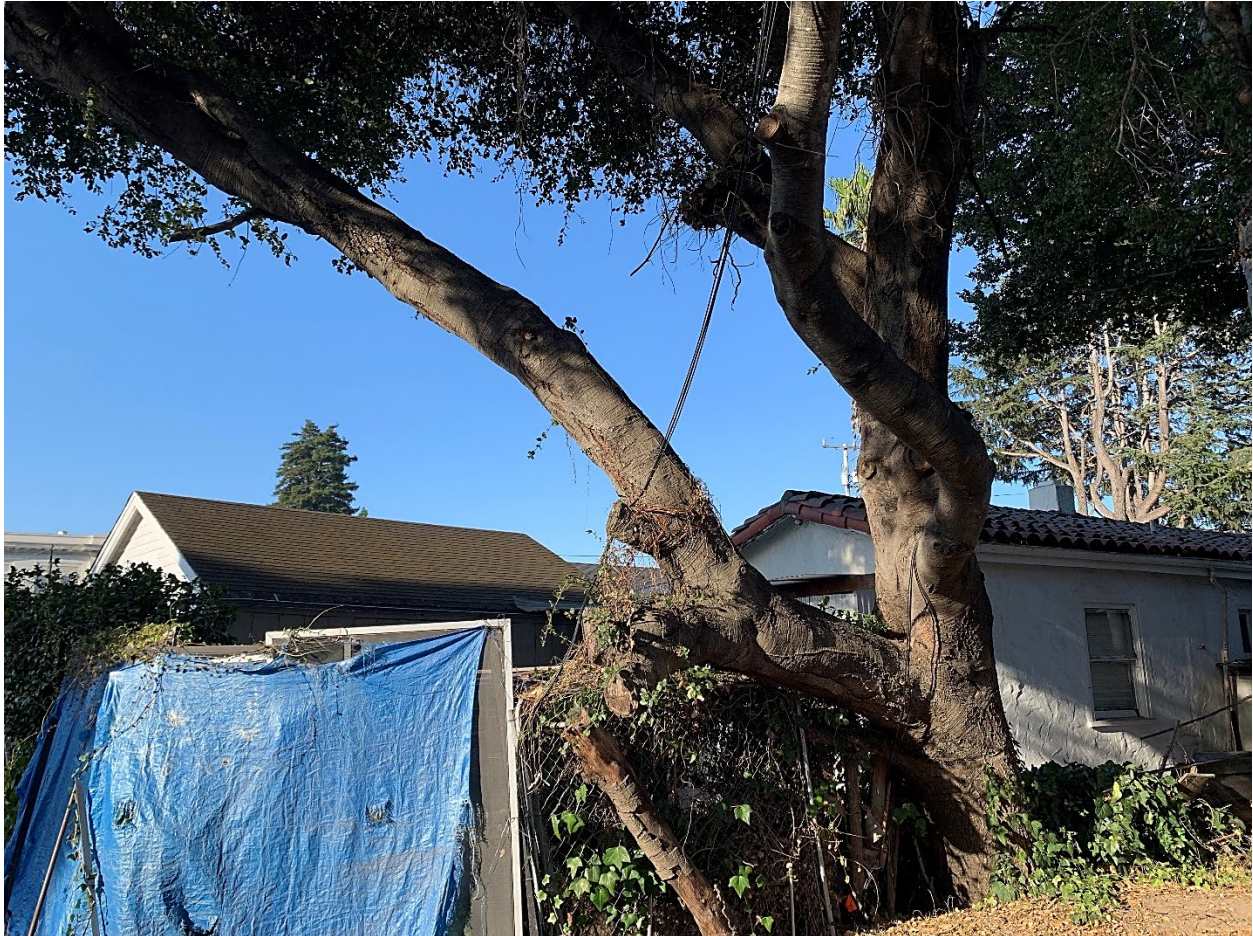
**Image #5 – Tree T4, coast live oak. One trunk grows to east towards applicants' property.**

One of the trunks grows east towards the applicant's property. Several limbs between 3" and 10" in diameter overhang the applicant's property.

The oak is vigorous with good canopy density and is in good health.

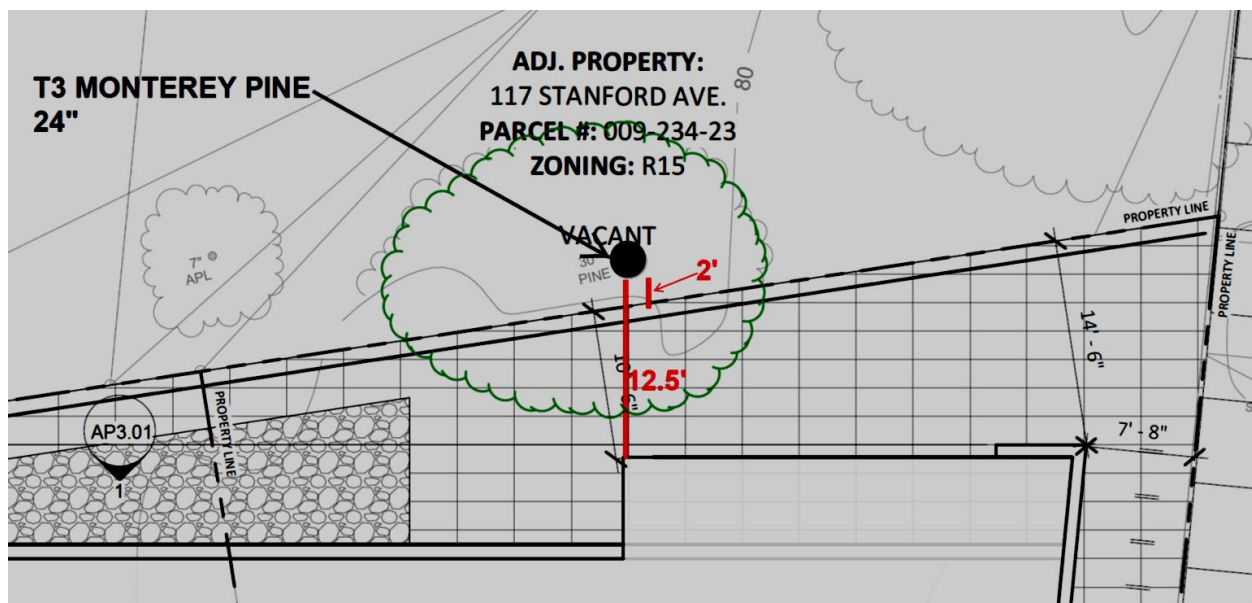
Tree T3, a 24" diameter Monterey pine is 12.5 feet from the building foundation, (Image #6).

Image #6 – Tree T3, Monterey pine, and distance to building foundation and property line.

This is outside the critical root zone,  $12.5' \times 12' \div 24''$  trunk diameter = 6.25X the trunk diameter. The pine can tolerate estimated root loss impacts at this distance and will need tree protection treatments to reduce root loss impacts.

The pine is 2 feet from the property line. If hardscape is installed adjacent to the tree it would need to be a minimum of 6 feet from the tree:  $6' \times 12' \div 24''$  trunk diameter = 3X the trunk diameter. The pine can tolerate estimated root loss impacts at this distance, and would need tree protection treatments to reduce root loss impacts.

If over excavation is required for the foundation (estimated at 5'), it would be within the pine's critical root zone,  $7.5' \times 12' \div 24''$  trunk diameter = 3.75X the trunk diameter. Excavation for the foundation could exceed the tree's root loss tolerance. Many anchoring roots could be cut, and the trees stability could be affected. If excavation occurs at this distance, pre-construction root exploration would be necessary to determine the number, size and location of roots that would need to be pruned. With this information a determination to remove or retain the tree could be made.

Minor canopy clearance pruning from the building may also be necessary for pine tree, T3..

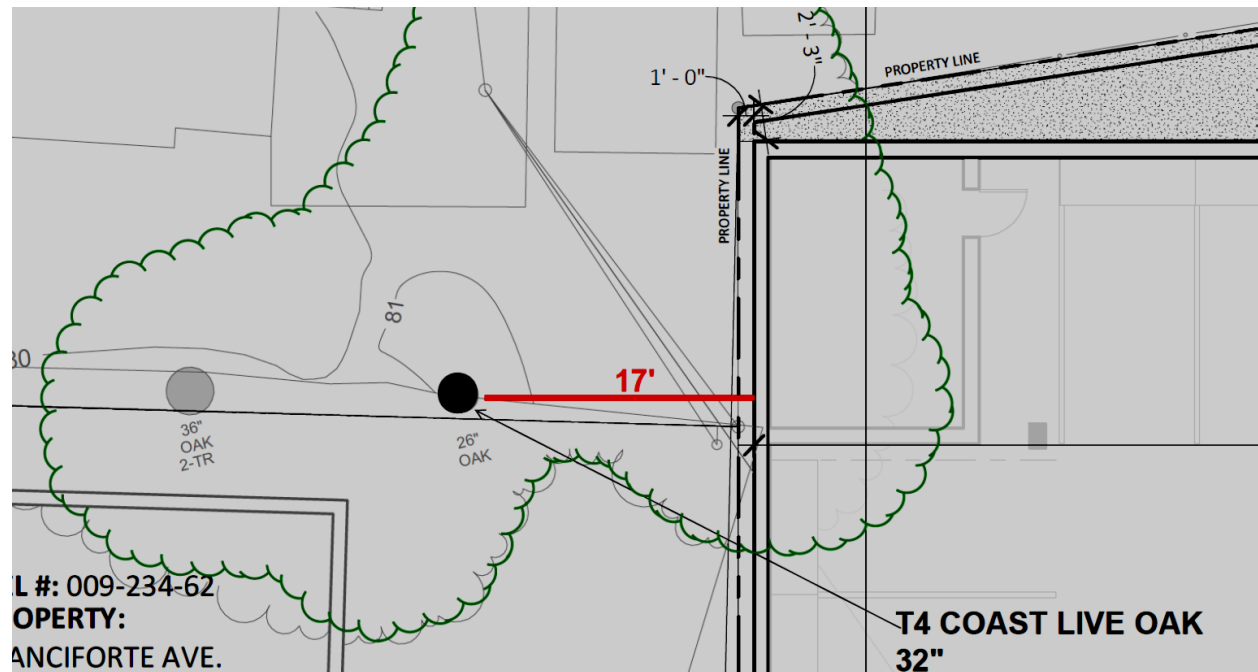
Tree T4, a 32" coast live oak is 17-feet from the building foundation, (Image #7).

Image #7 – Tree T4, coast live oak, and distance to building foundation.

This is outside the critical root zone,  $17 \times 12" \div 32" \text{ trunk diameter} = 6.4X$  the trunk diameter. The oak can tolerate estimated root loss impacts at this distance and would need tree protection treatments to reduce root loss impacts.
