**ARBORIST REPORT-**  
**Tree Resource Evaluation & Project Impact Analysis**

Peace Church  
900 High Street  
Santa Cruz, CA  
APN: 001-022-40

**9/25/2022**  
Addendum Date 12/13/2025

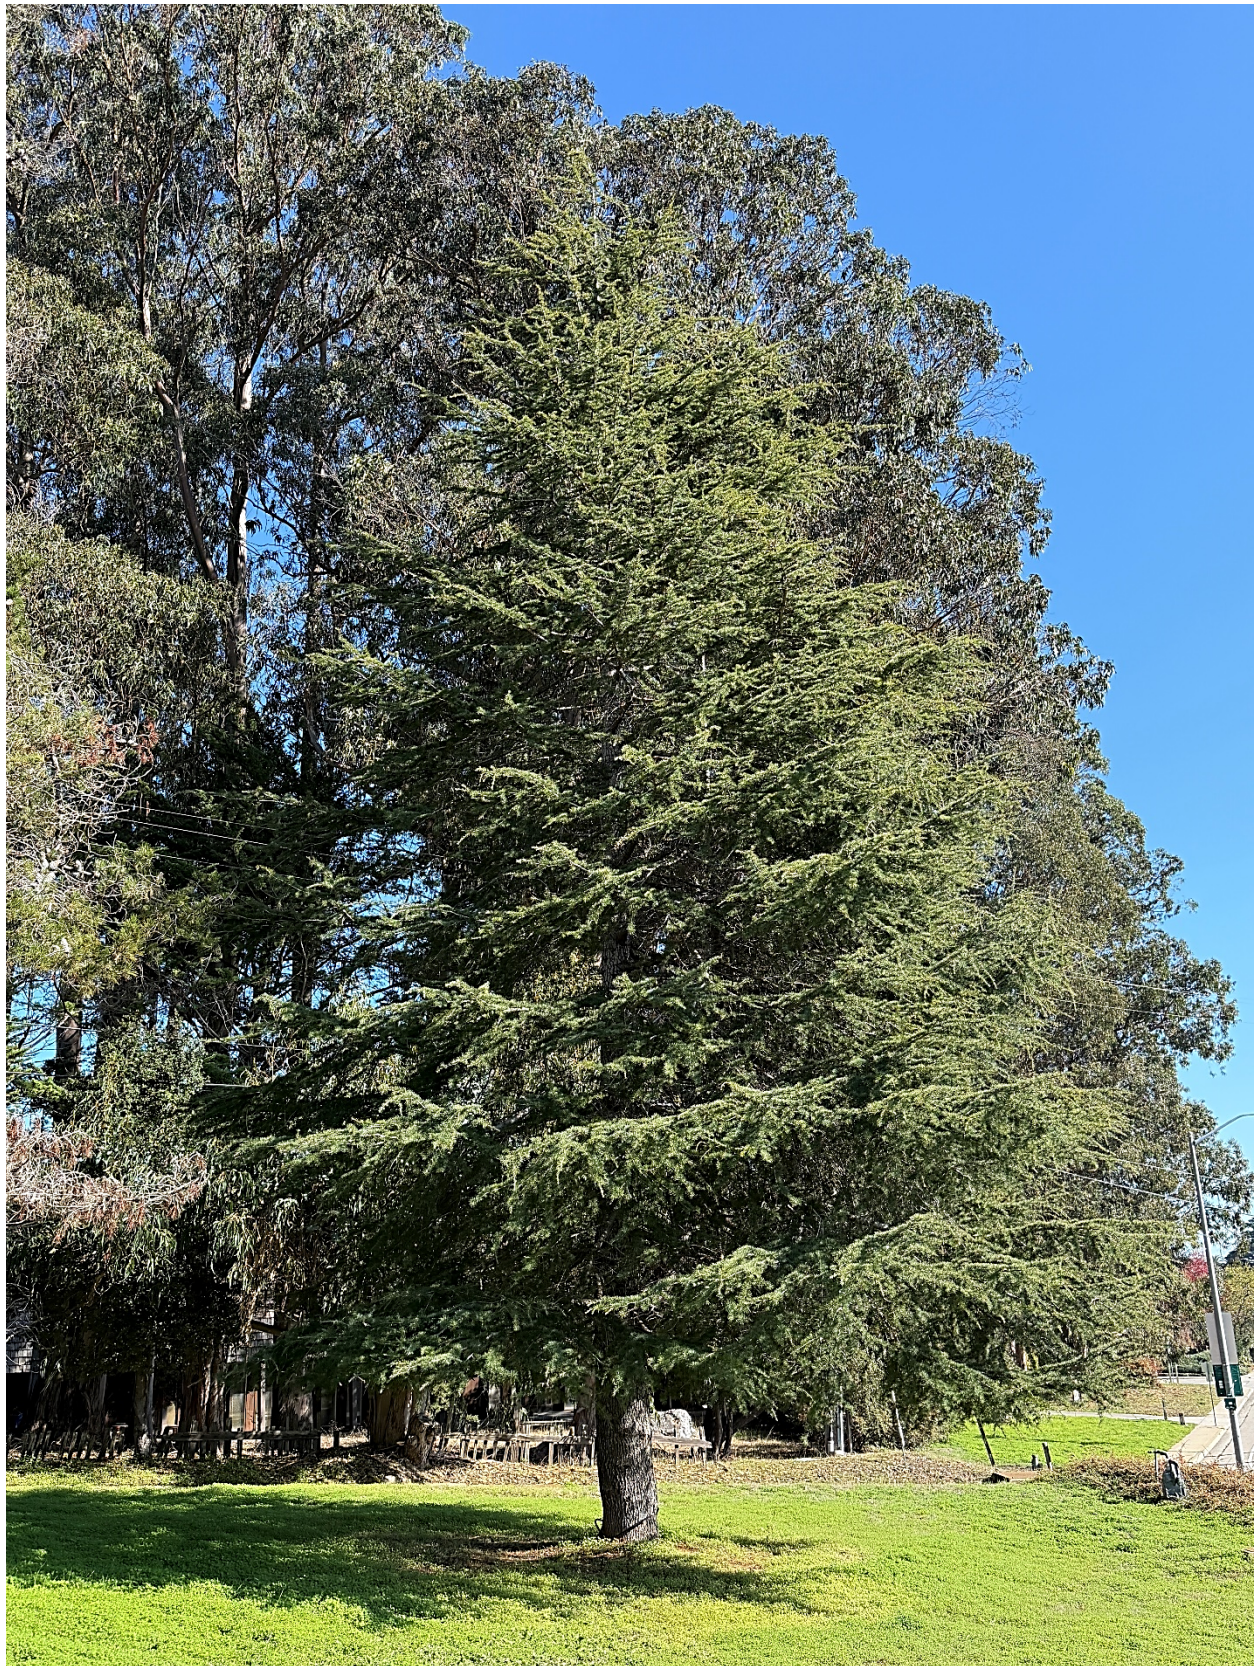
**Image #1 – Tree T174, cedar. The cedar is in good condition.**

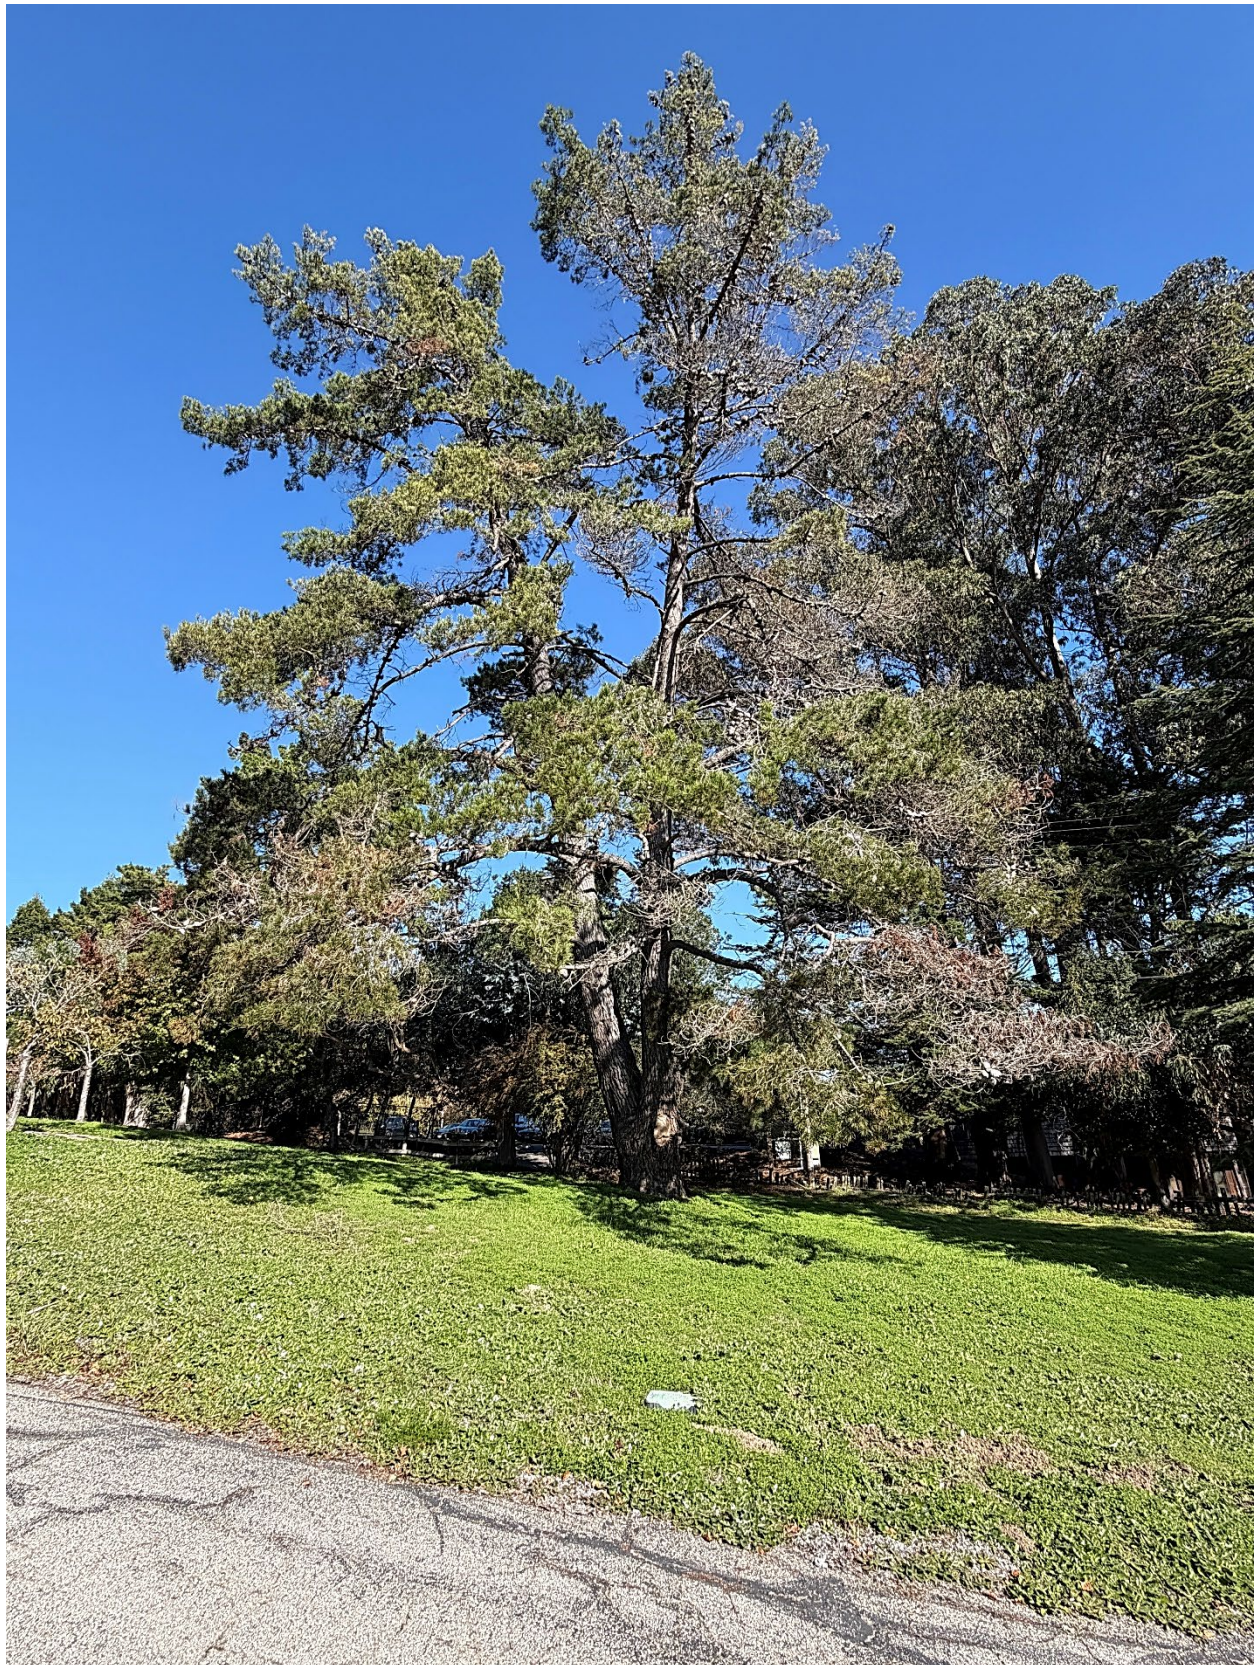
**Image #2 – Tree T175, Monterey pine. The pine is in fair condition. Note trunk on right has several areas of canopy dieback.**

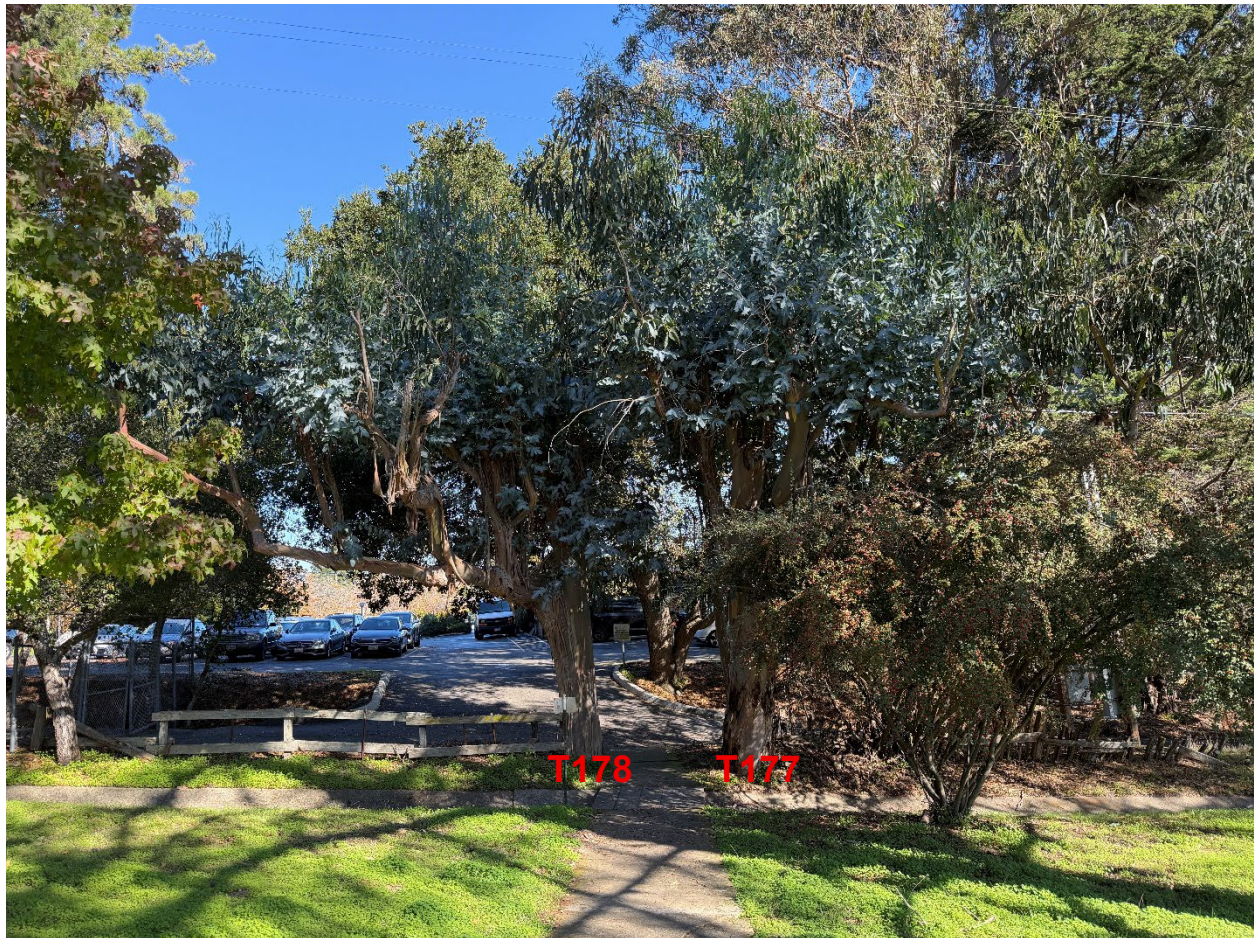
**Image #3 – Trees T177 and T178, blue gum eucalyptus. The two eucalypti are in fair condition. Note that both trees have been topped at 25' above grade for overhead power line clearance.**

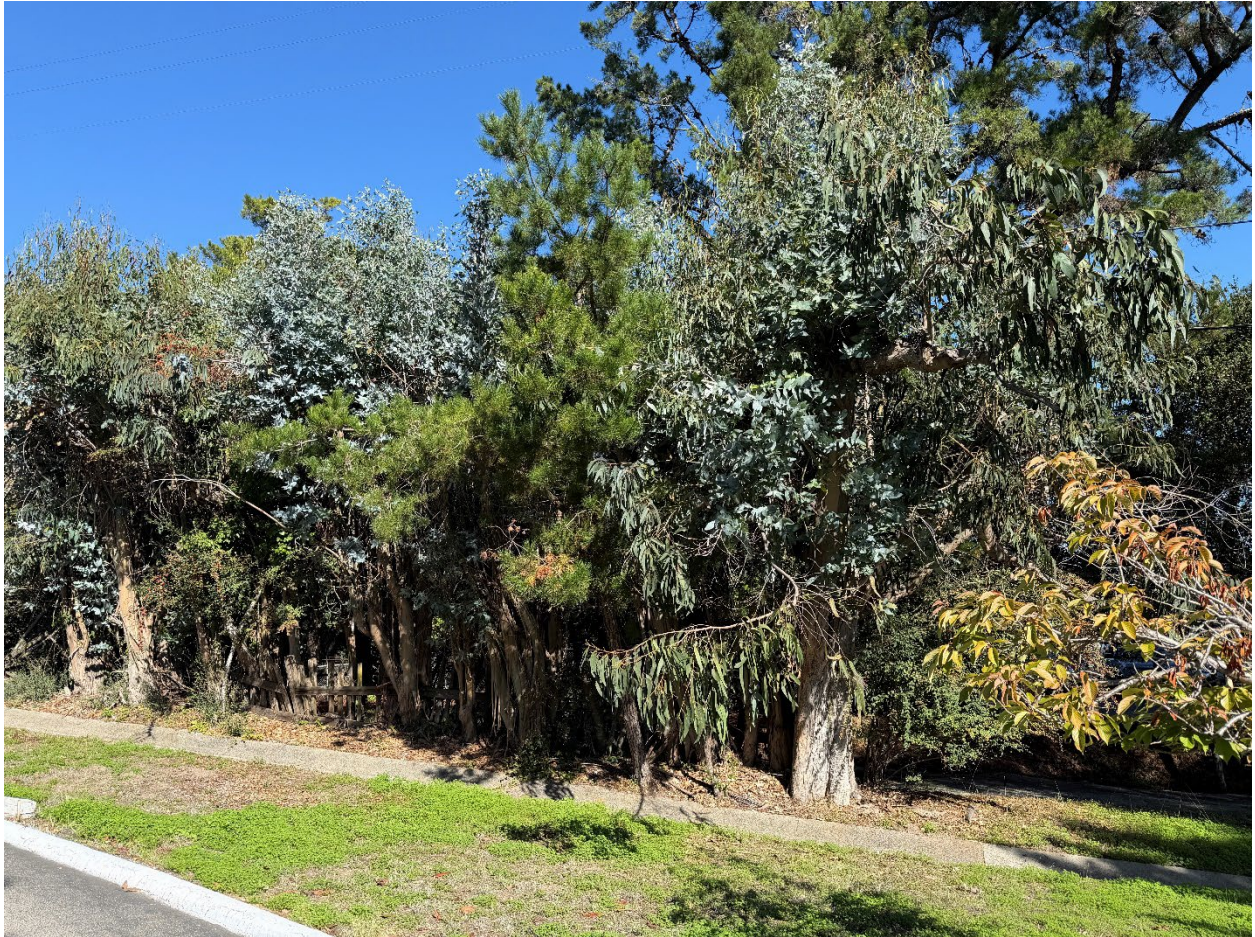
**Image #4 – Tree T179. This is a hedge row of about 14 trees that have all been maintained as a screening hedge. Because of their close spacing and use as a hedge, the individual trees are all counted as one tree, T179. Within this hedge there are a handful of Heritage size trees.**

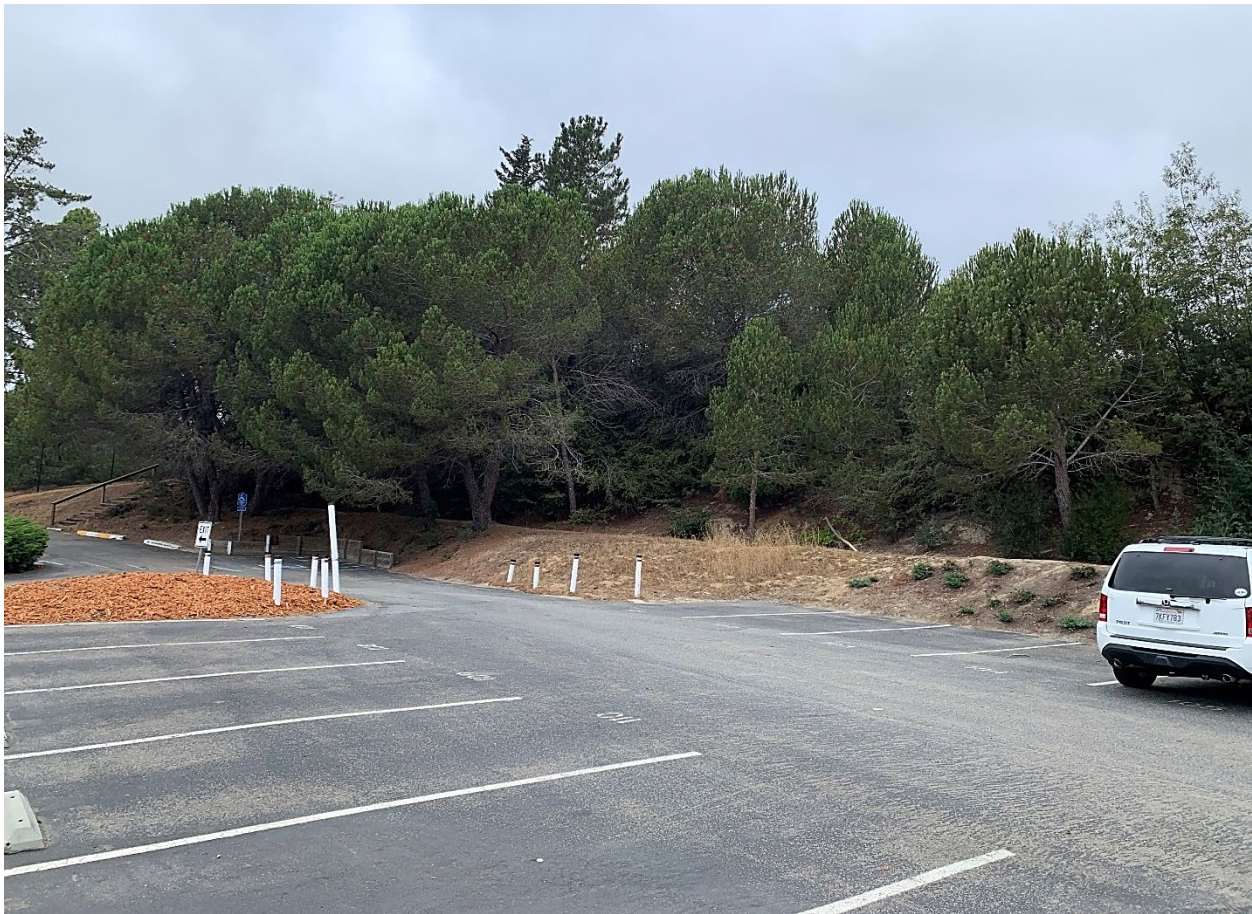
Image #2 – Italian stone pine. Grow at southwest corner of project site.

The pines are in good or fair condition.

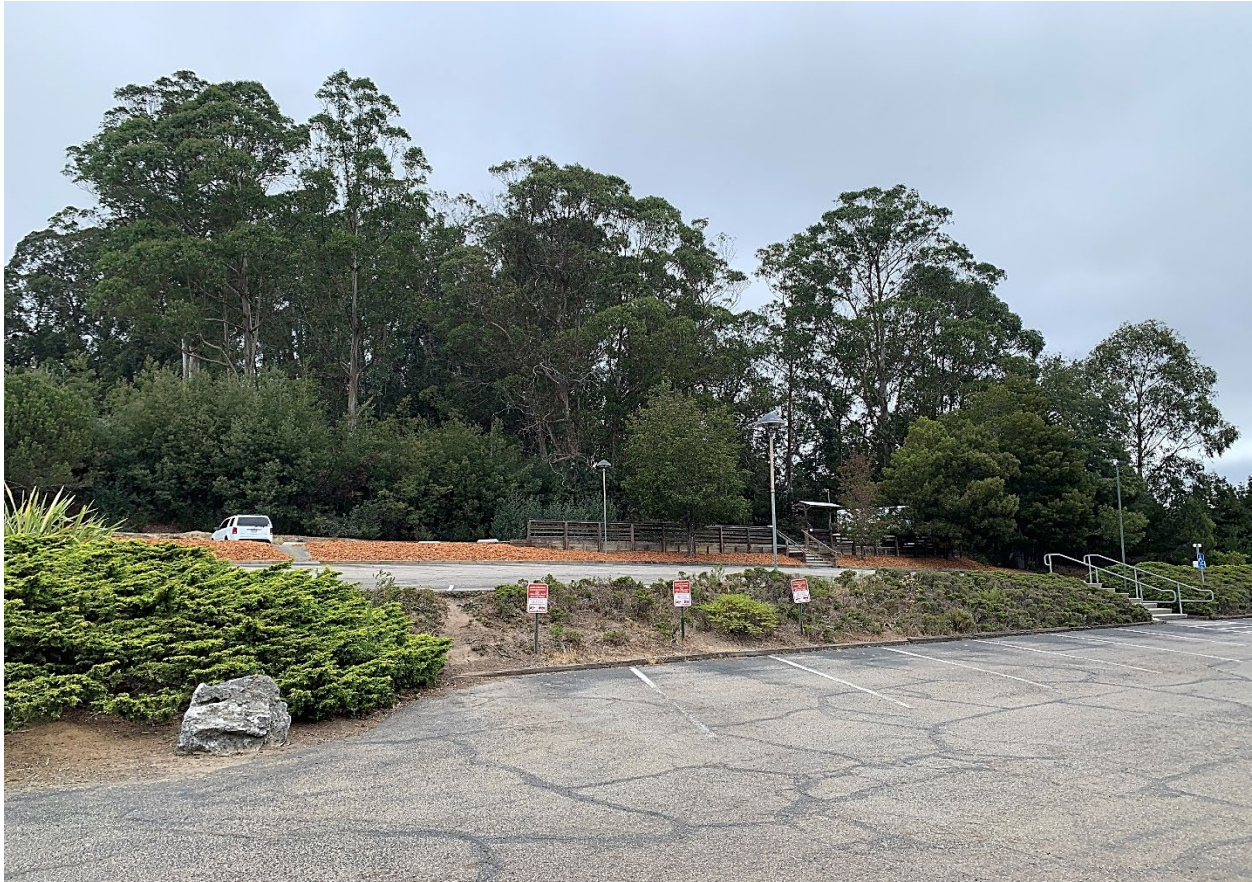
**Image #3 – Blue gum eucalyptus, taller background trees, growing along the east perimeter of the parcel.**

The blue gum species make up the largest group of *Heritage Trees*. Many have structural defects including co-dominant trunks with included bark<sup>2</sup>, trunk leans, unbalanced canopies, and over extended limbs.

Of the defects listed, overextended limbs are the defect most likely to result in failure. Overextended limbs grow beyond the main canopy and may have poor taper relative to their length. Such limbs are more likely to fail due to excessive mechanical stress on the limb.

Two-thirds of the blue gums are in fair condition, with one-third in poor condition.

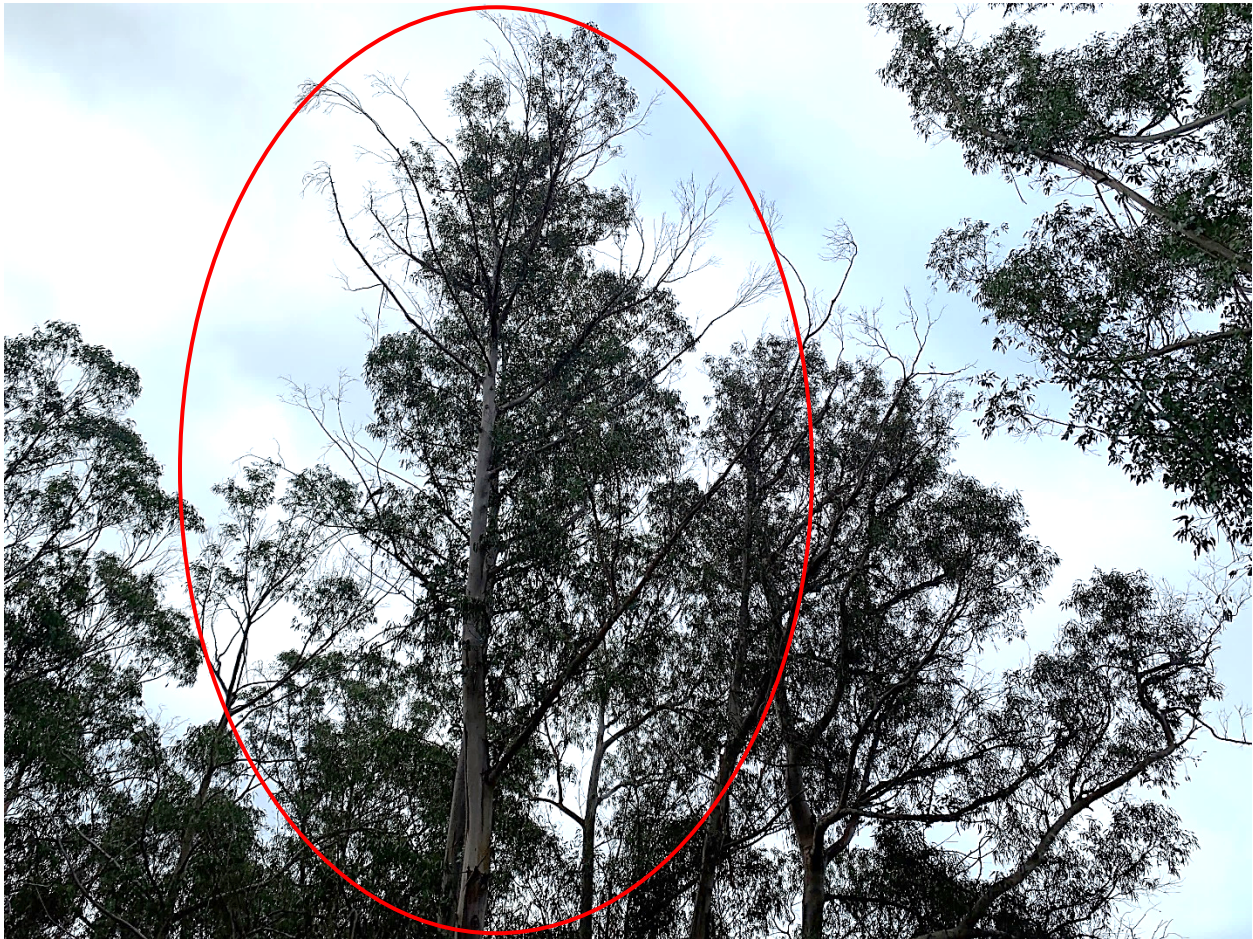
Blue gum eucalyptus in poor condition have tip dieback, (Image #4), and in some cases, thin canopy density.

**Image #4 – Blue gum eucalyptus in poor condition, (circled). Note tip dieback on limbs.**

Tip dieback in eucalyptus may be caused by root disease. Soil borne fungi such as *phytophthora spp.*, are know to cause tip and branch dieback in the eucalyptus species. Tip dieback can also occur due to water deficit.

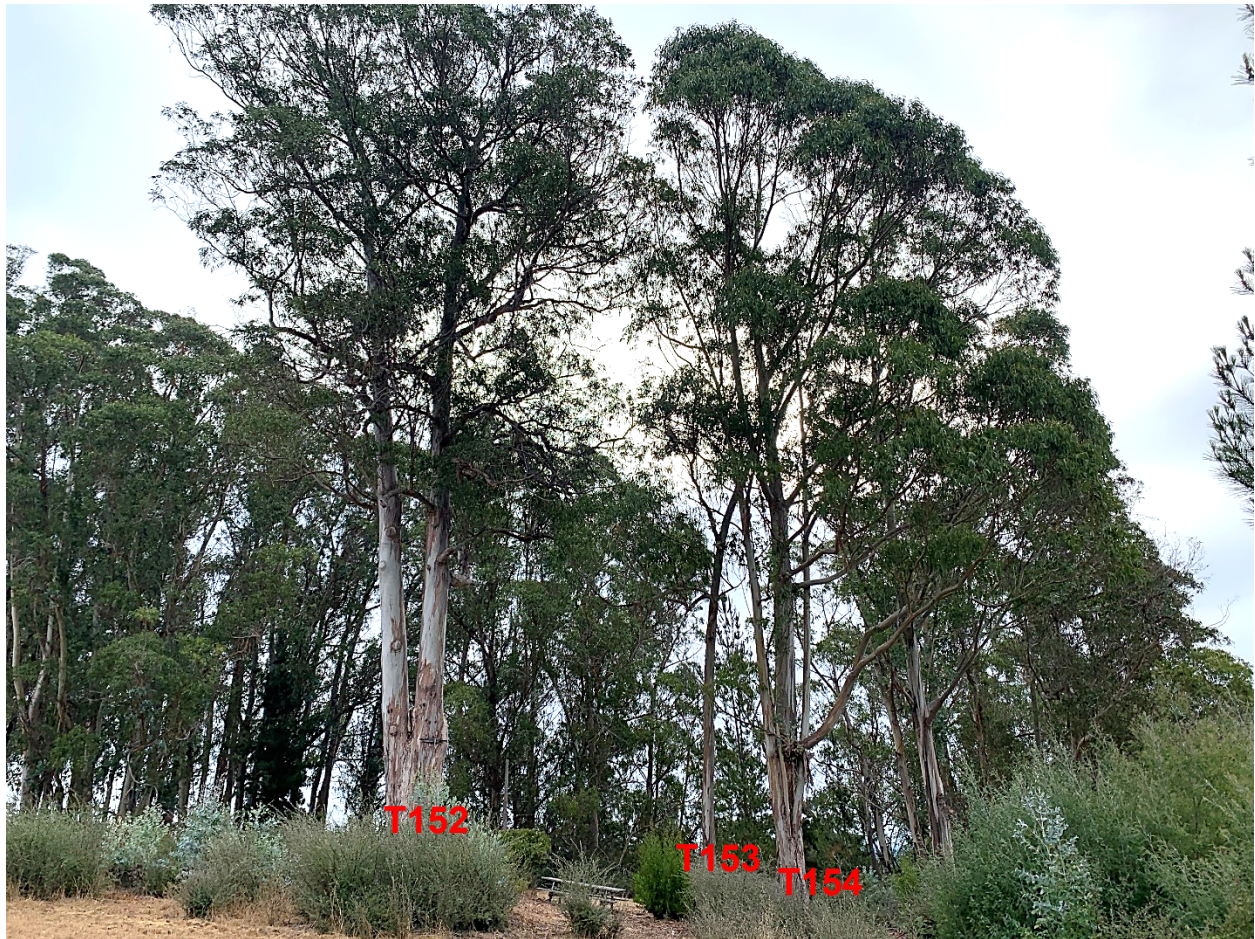
**Image #5 – Tree T152, T153 & T154, blue gum eucalyptus. The trees grow on the upper terrace.**

Blue gums T152 and T154 are in fair condition. Tree T153 has a trunk bow, limited branch structure, and is in poor condition.

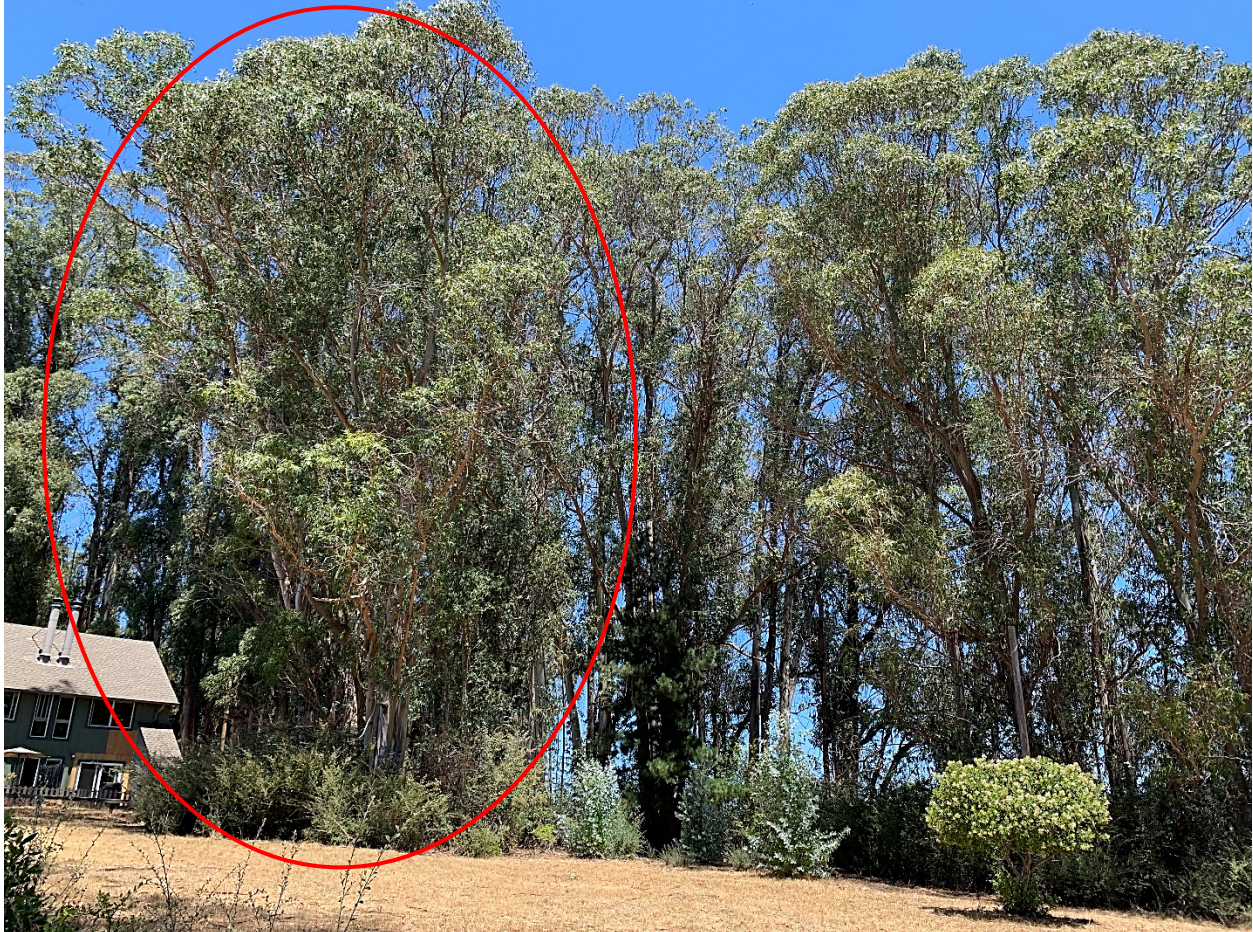
**Image #6 – Trees T149, T150 & T151, blue gum eucalyptus, (circled).**

Blue gums T149 – T151, grow in the northeast corner of the parcel, and are in fair condition.

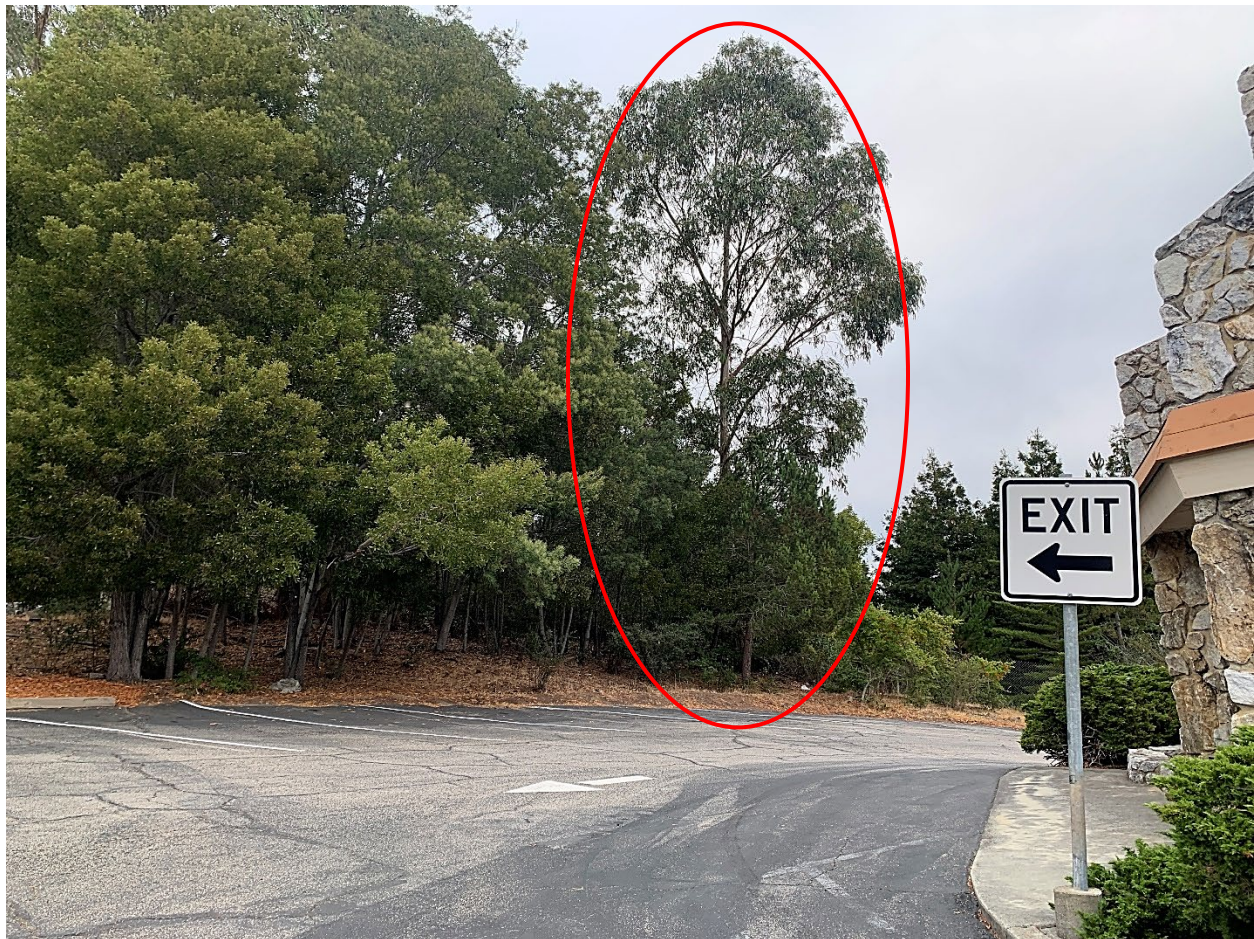
**Image #7 – Blackwood acacia growing in southeast corner of project. Tree T133, blue gum eucalyptus, (circled), grows at the southeast corner of the project limits.**

One of the blackwood acacia is heritage size and it is in poor condition. Most of the non-heritage acacias are in poor condition.

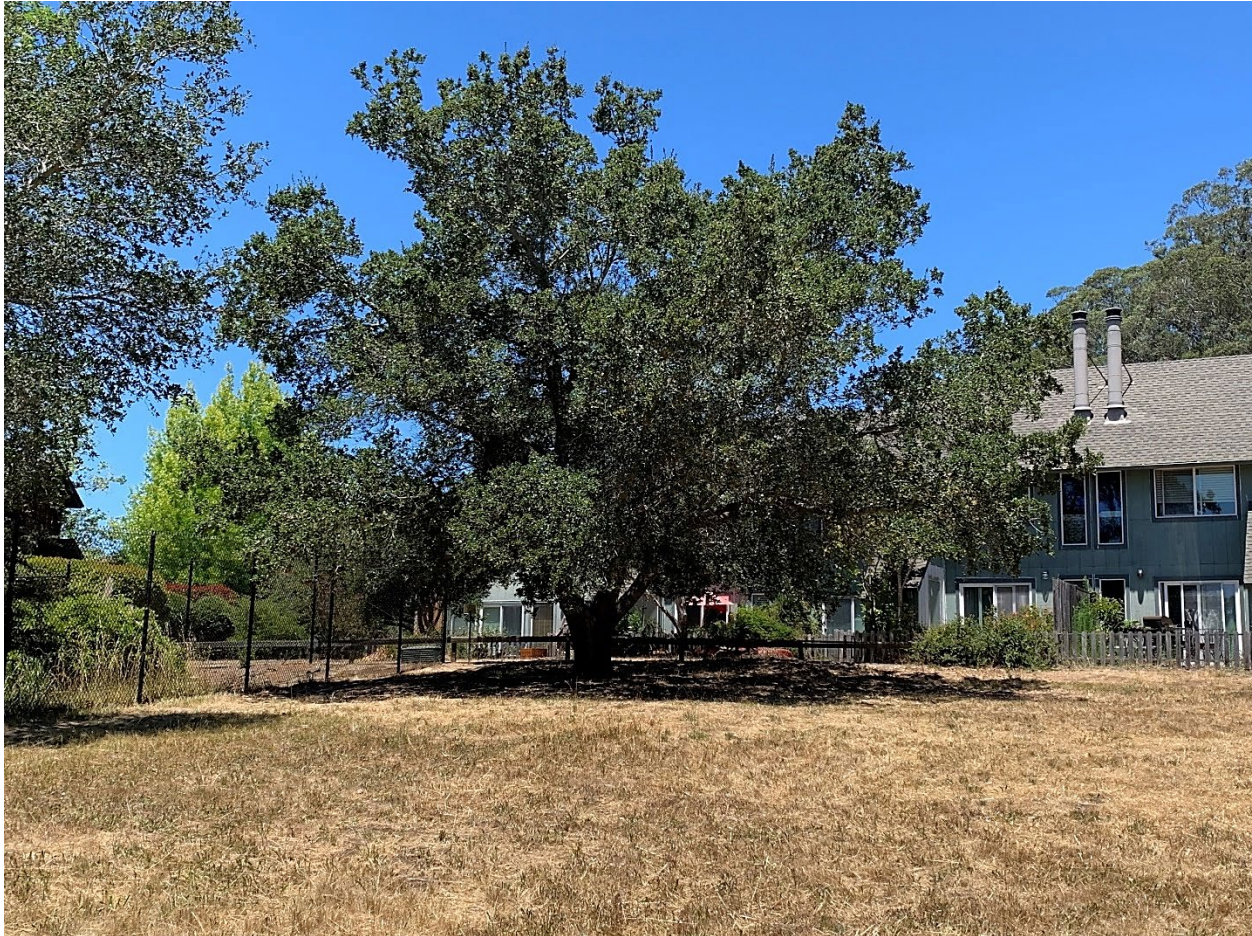
**Image #8 – Tree T166, coast live oak , grows in northwest corner of project limits.**

Limbs are well attached and the oak is in good condition.
