## APPENDIX C

### Historical Significance Diagrams

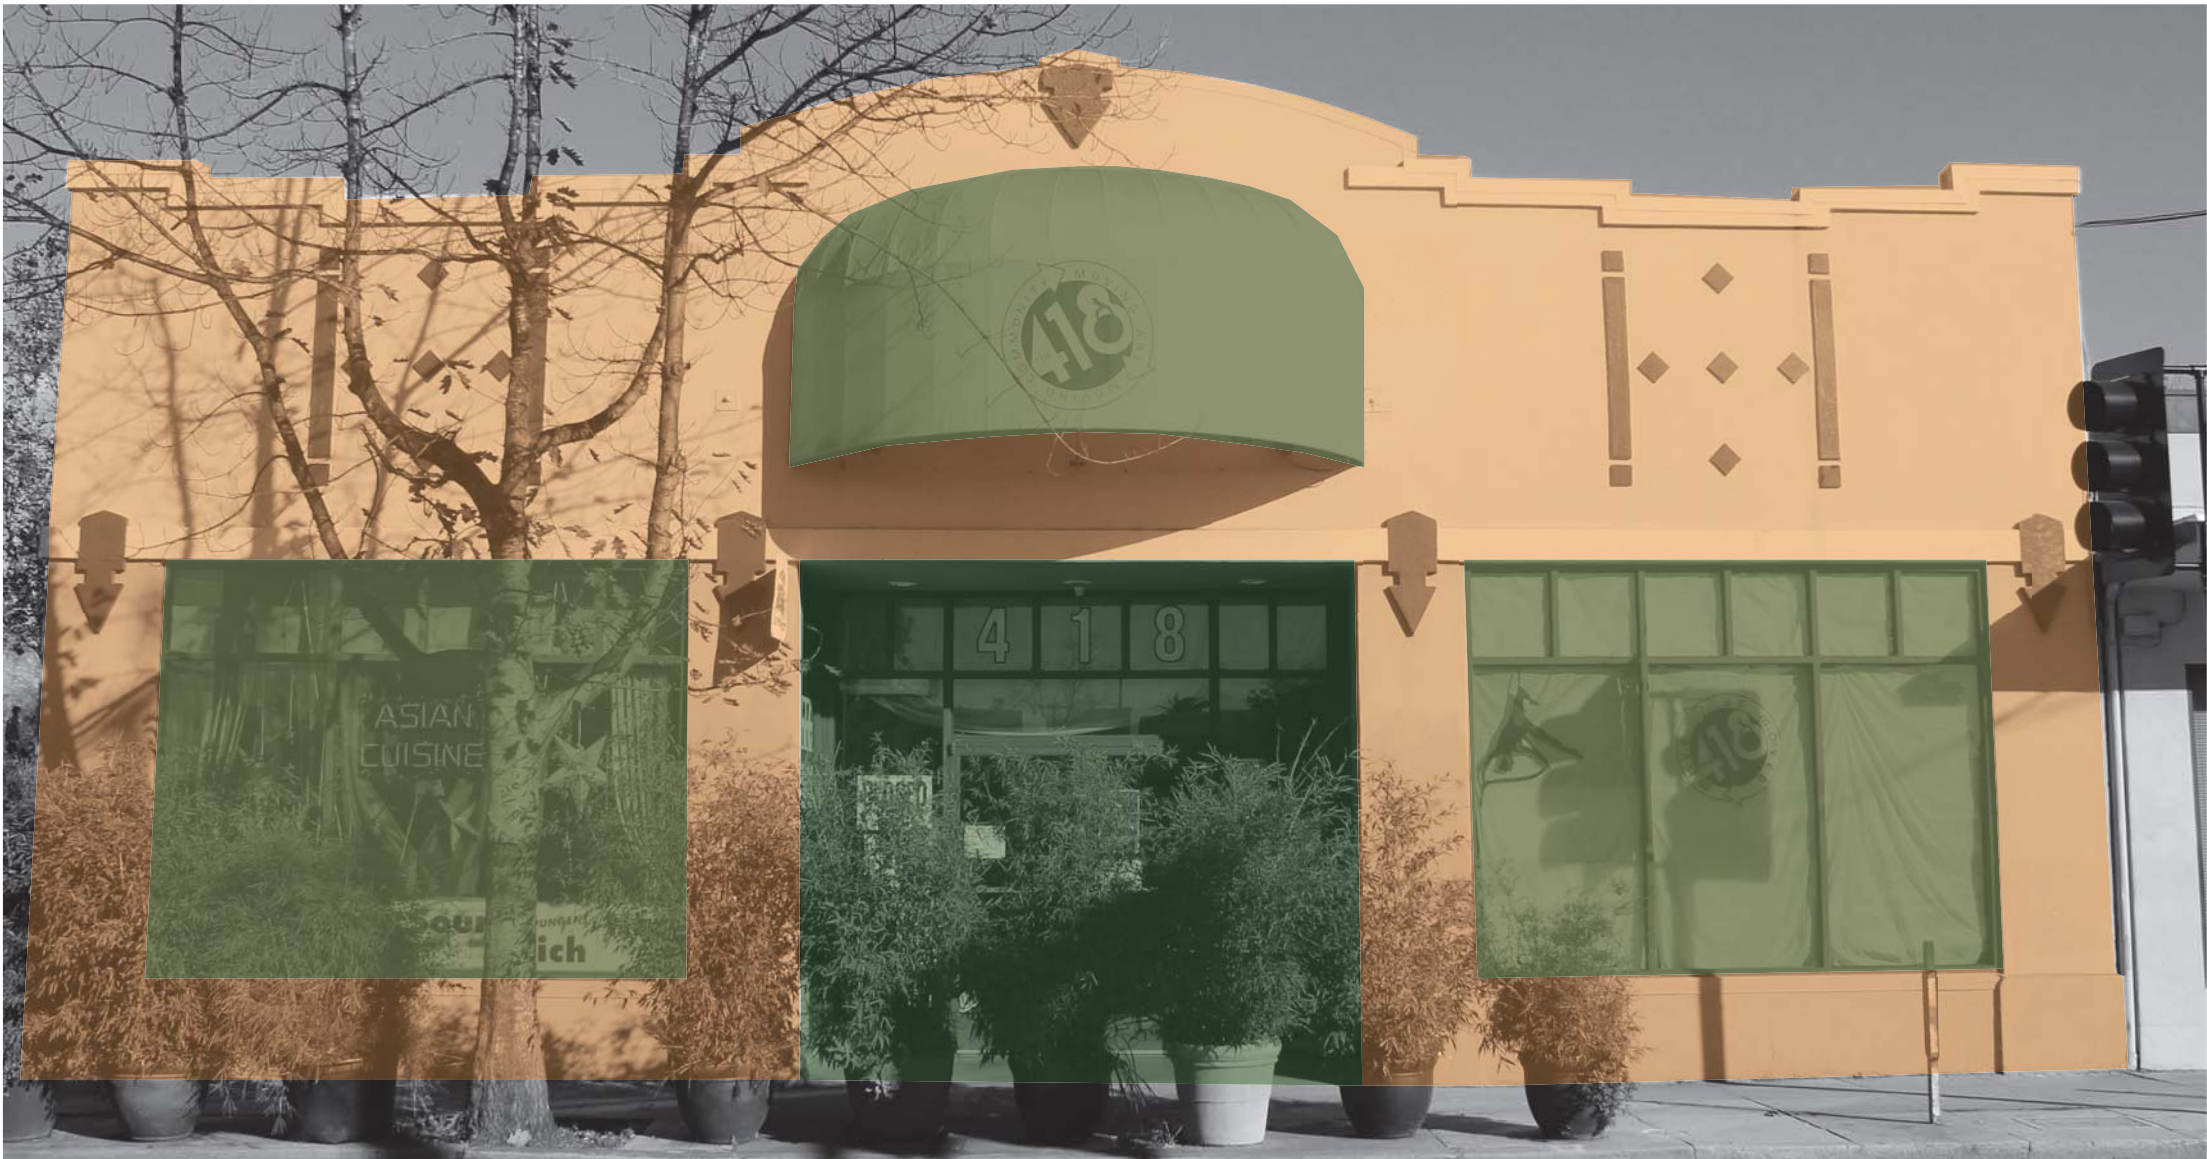
Significance Diagram: 418 Front Street-West Facade

- The primary (west) facade retains its Mission Revival style design and character-defining composition, despite replacement of original windows and main entry door.
- Fenestration contributes to the building's historic character, but components within the openings including muntins and glazing are non-contributing.
- The primary facade's stepped cornice and curved parapet are of primary significance.
- Art Deco detailing is of primary significance.

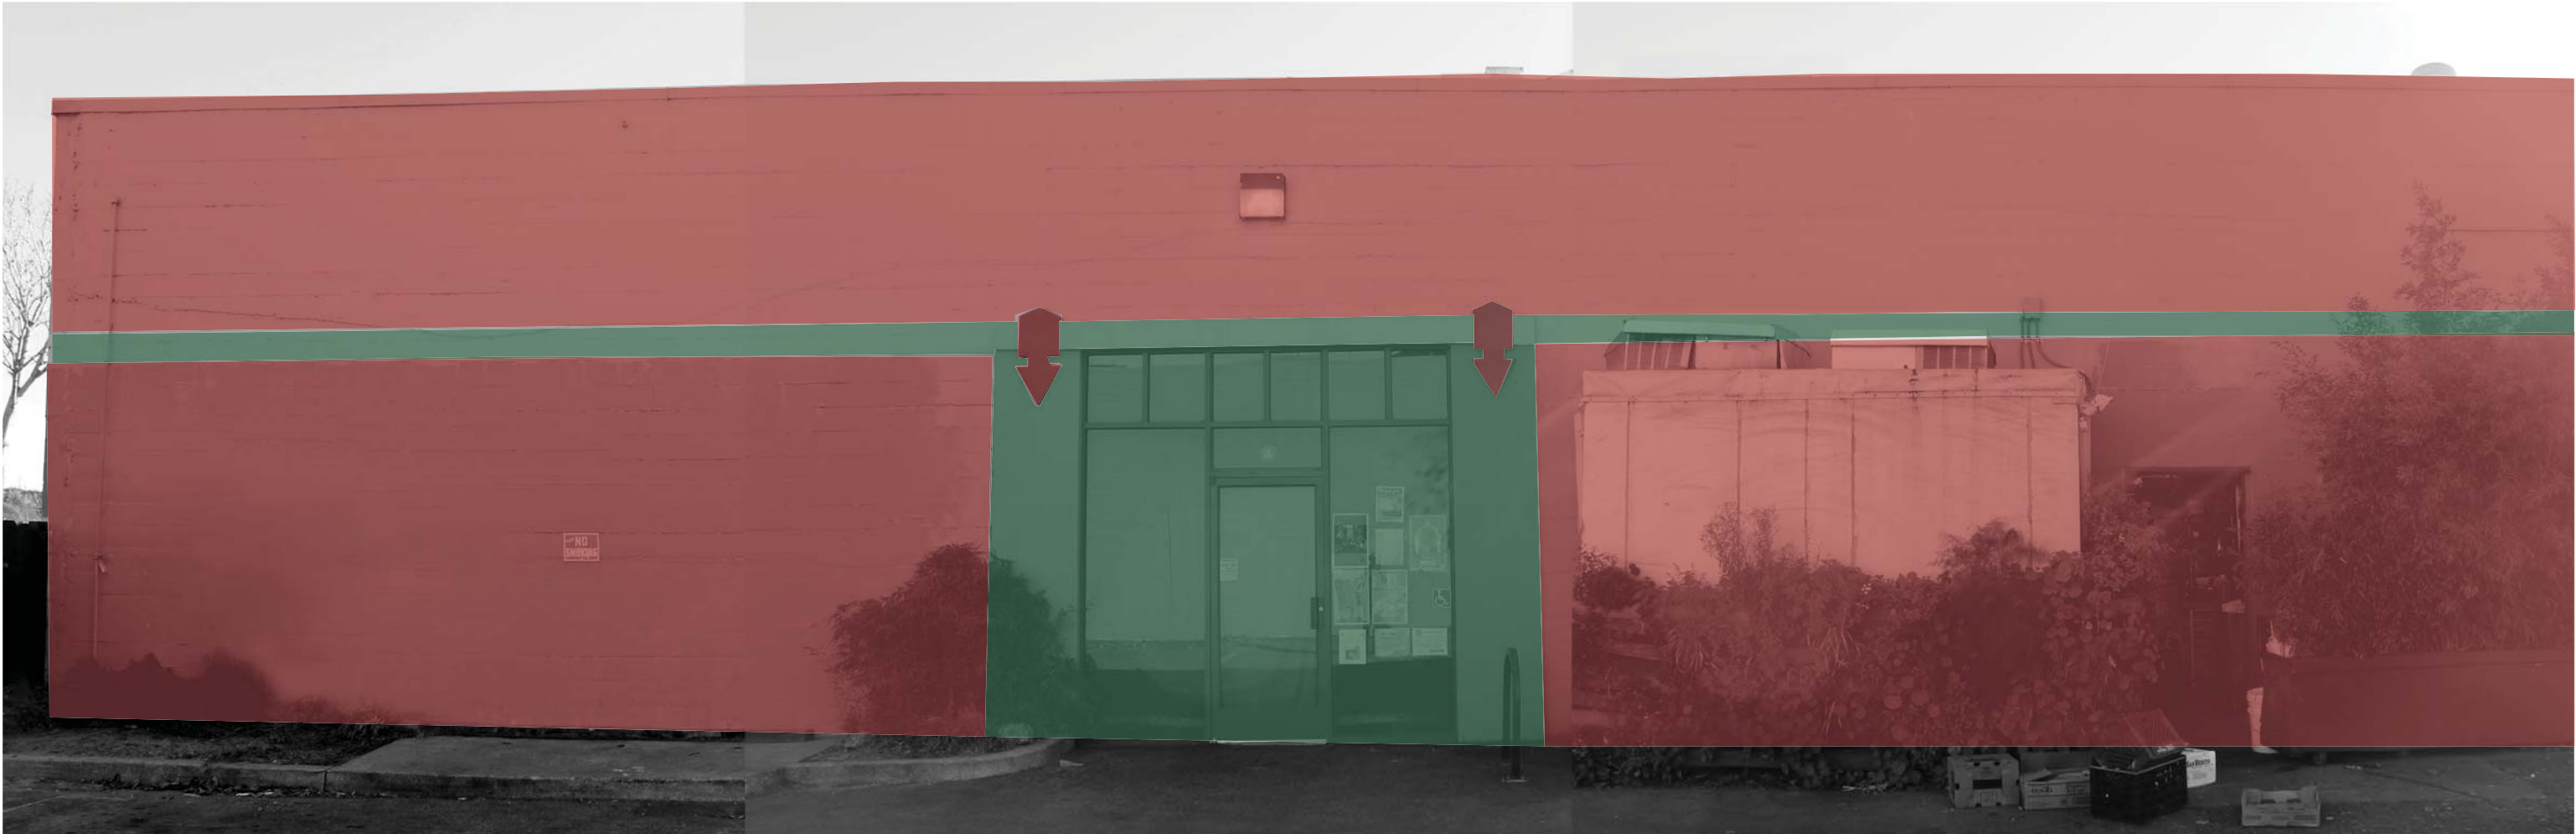
Significance Diagram: 418 Front Street-North Facade

- Opening, door frame, and plate glazing along north facade are non-contributing features that were added during renovation in 1992-1994.
- Arrowheads flanking opening do not correspond to a historic opening, but are associable to the building's original Art Deco detailing.
- The north facade appears to retain most of its original form aside from doorway alteration.

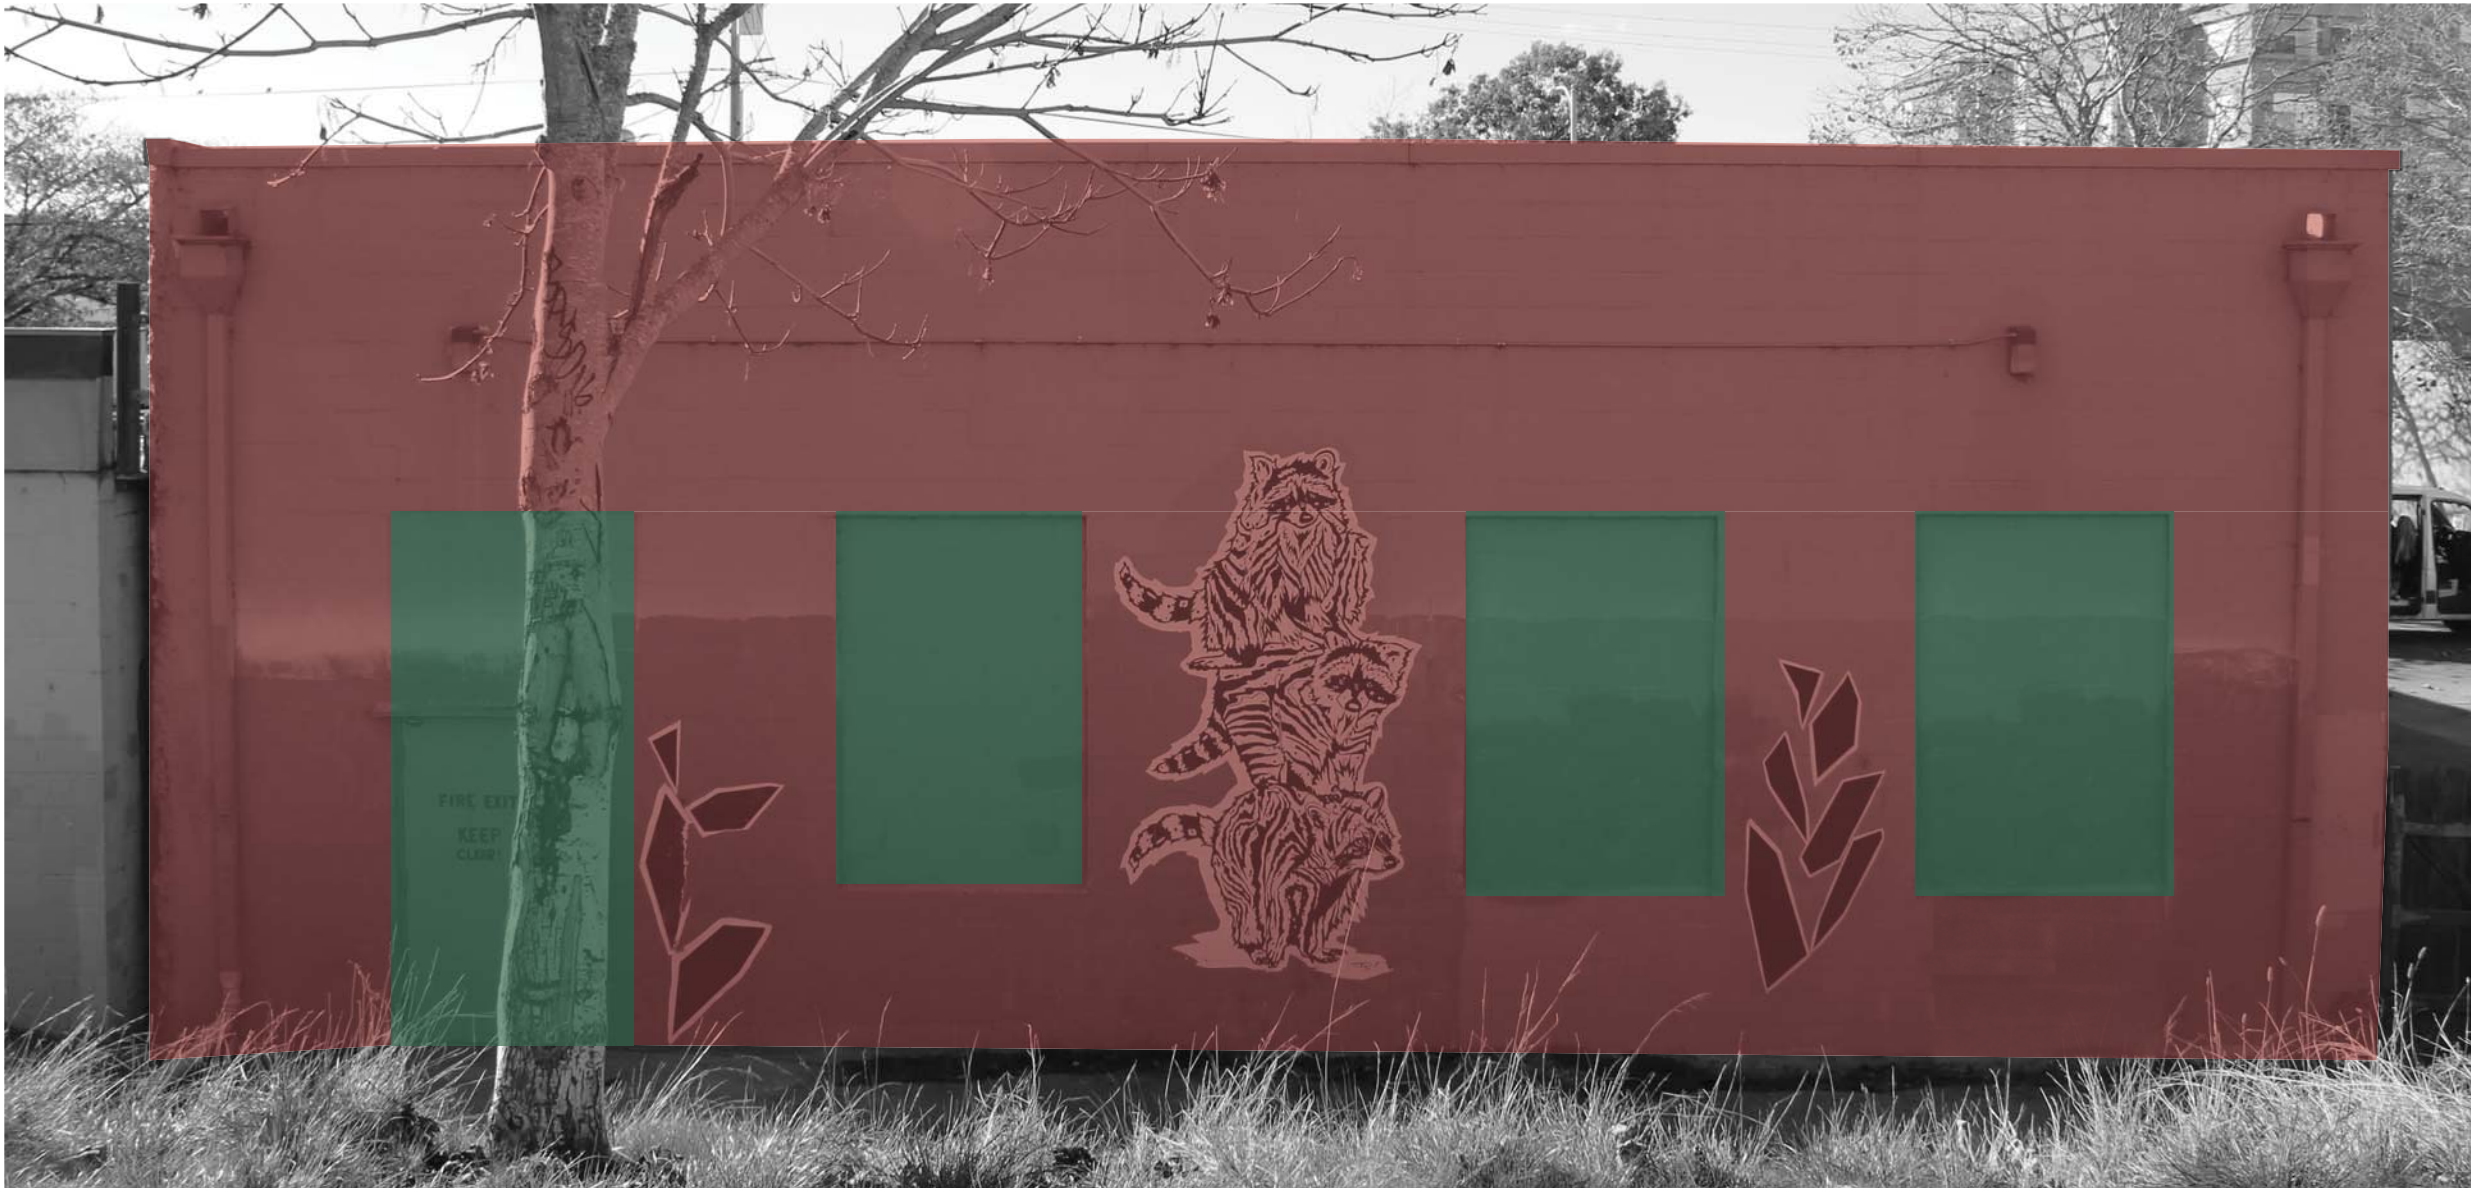
Significance Diagram: 418 Front Street-East Facade

- The rear (east) facade retains much of its original massing and design.
- Former window openings have been infilled with cmu and in one case replaced by a steel door.
- The location of the openings contributes to the building's character, but infill within the openings is non-contributing.

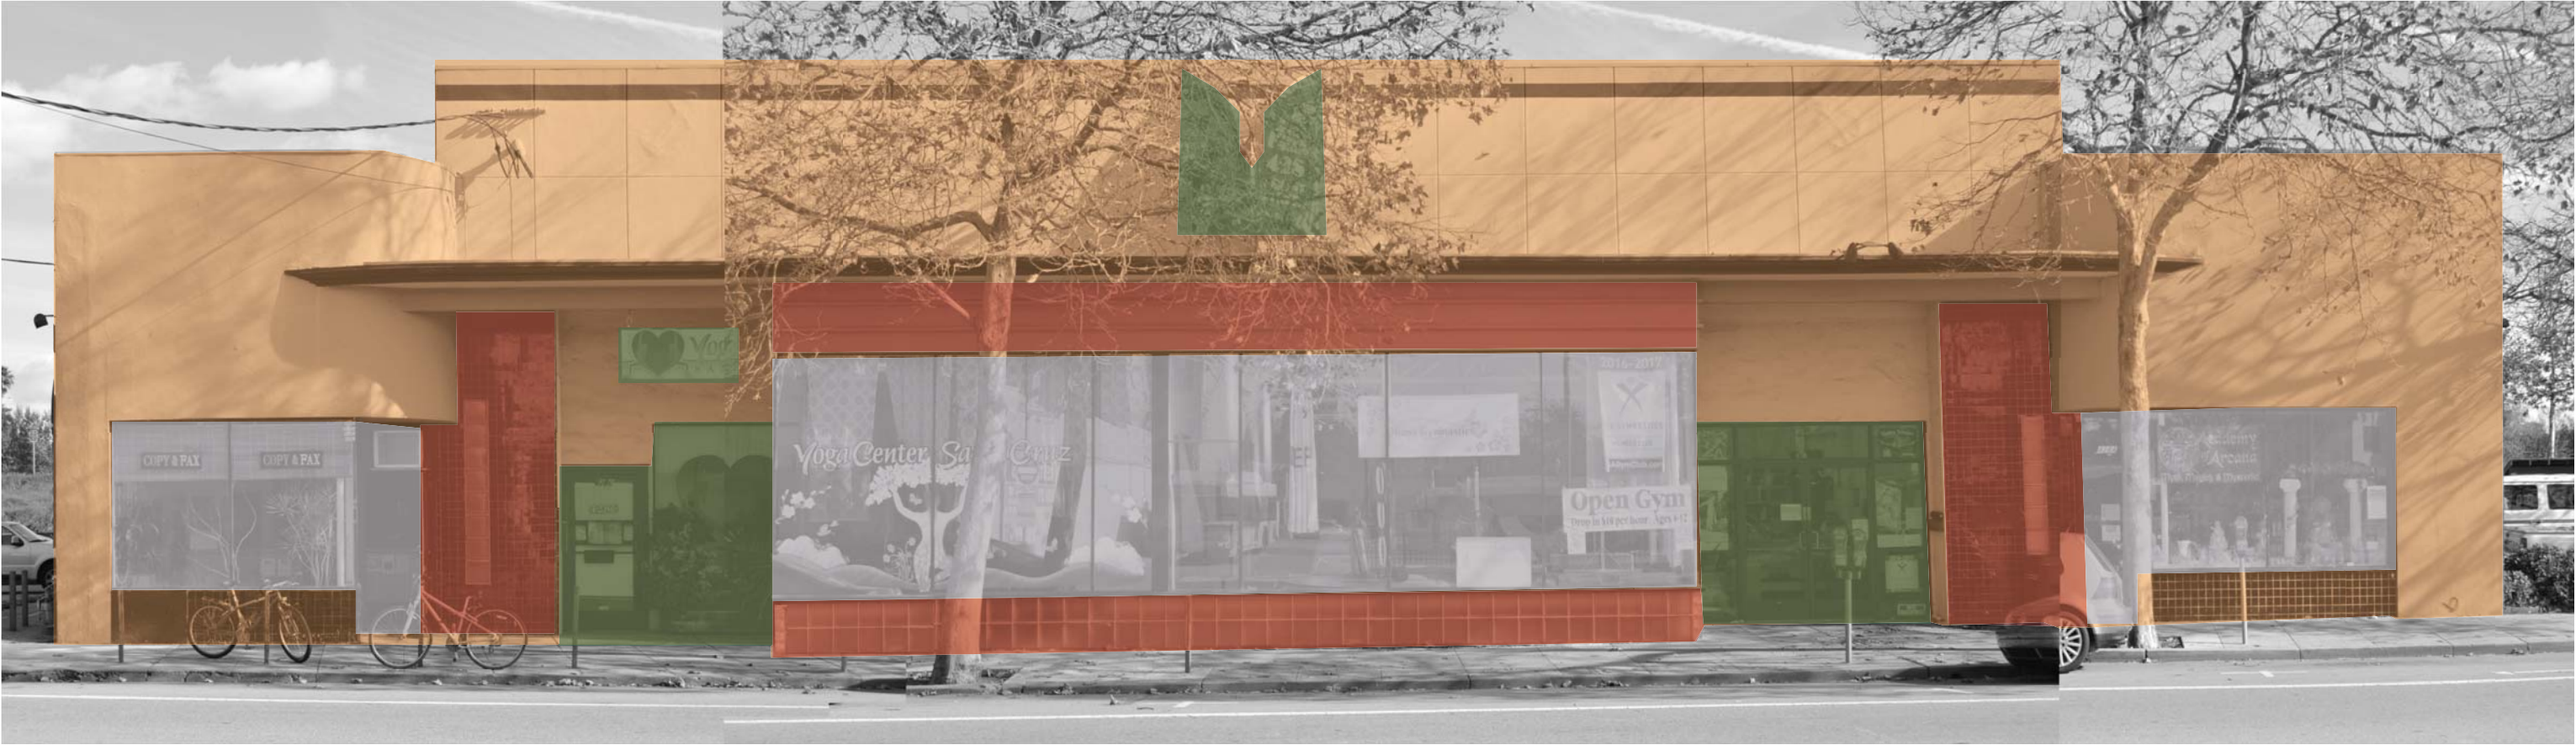
Significance Diagram: 428 Front Street-West Facade

- Articulation of the primary (west) facade's multiple surface planes is a primary, significant feature.
- Streamlined elements connect the primary facade's multiple surface planes and are of primary significance.
- Replacement display windows are contributing features.
- Recessed door ways and door components and signage at the top-center of the facade are non-contributing features.

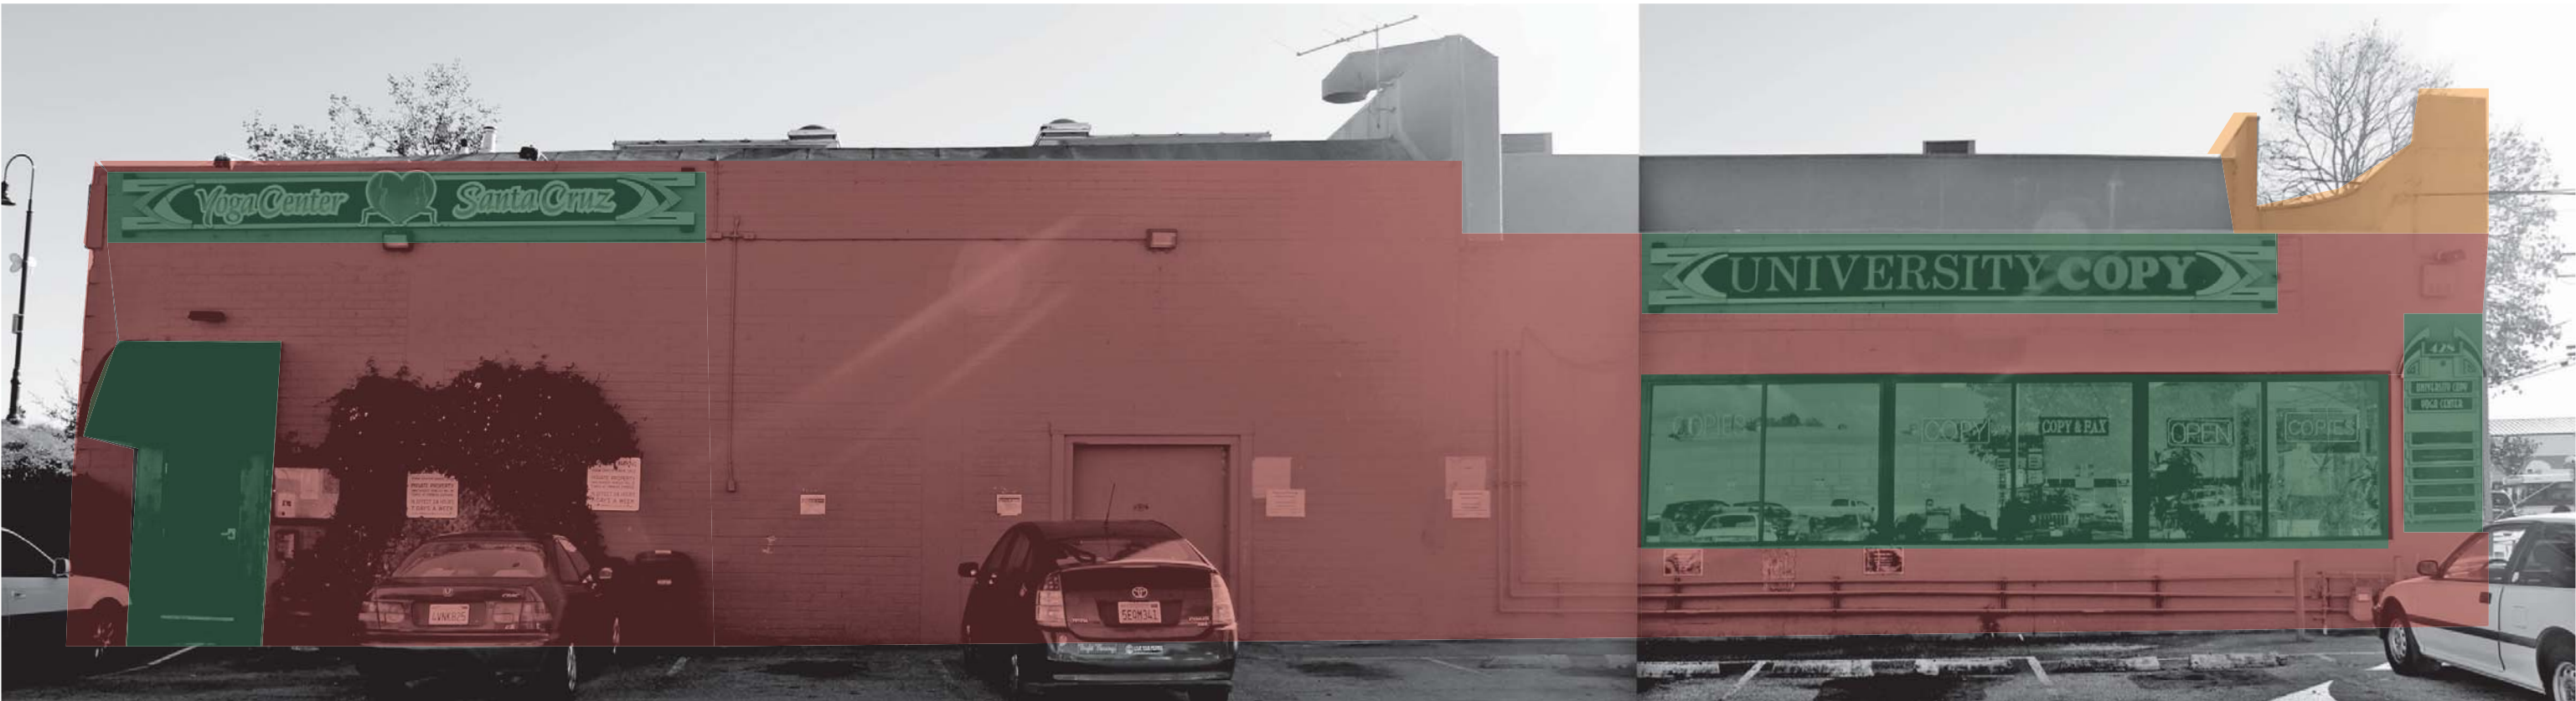
Significance Diagram: 428 Front Street-North Facade

- The north facade contributes to the building’s overall character, but has undergone notable alteration.
- Windows added in 1987 are non-contributing features.
- A portion of the primary facade’s significant parapet line is connected to the north facade.

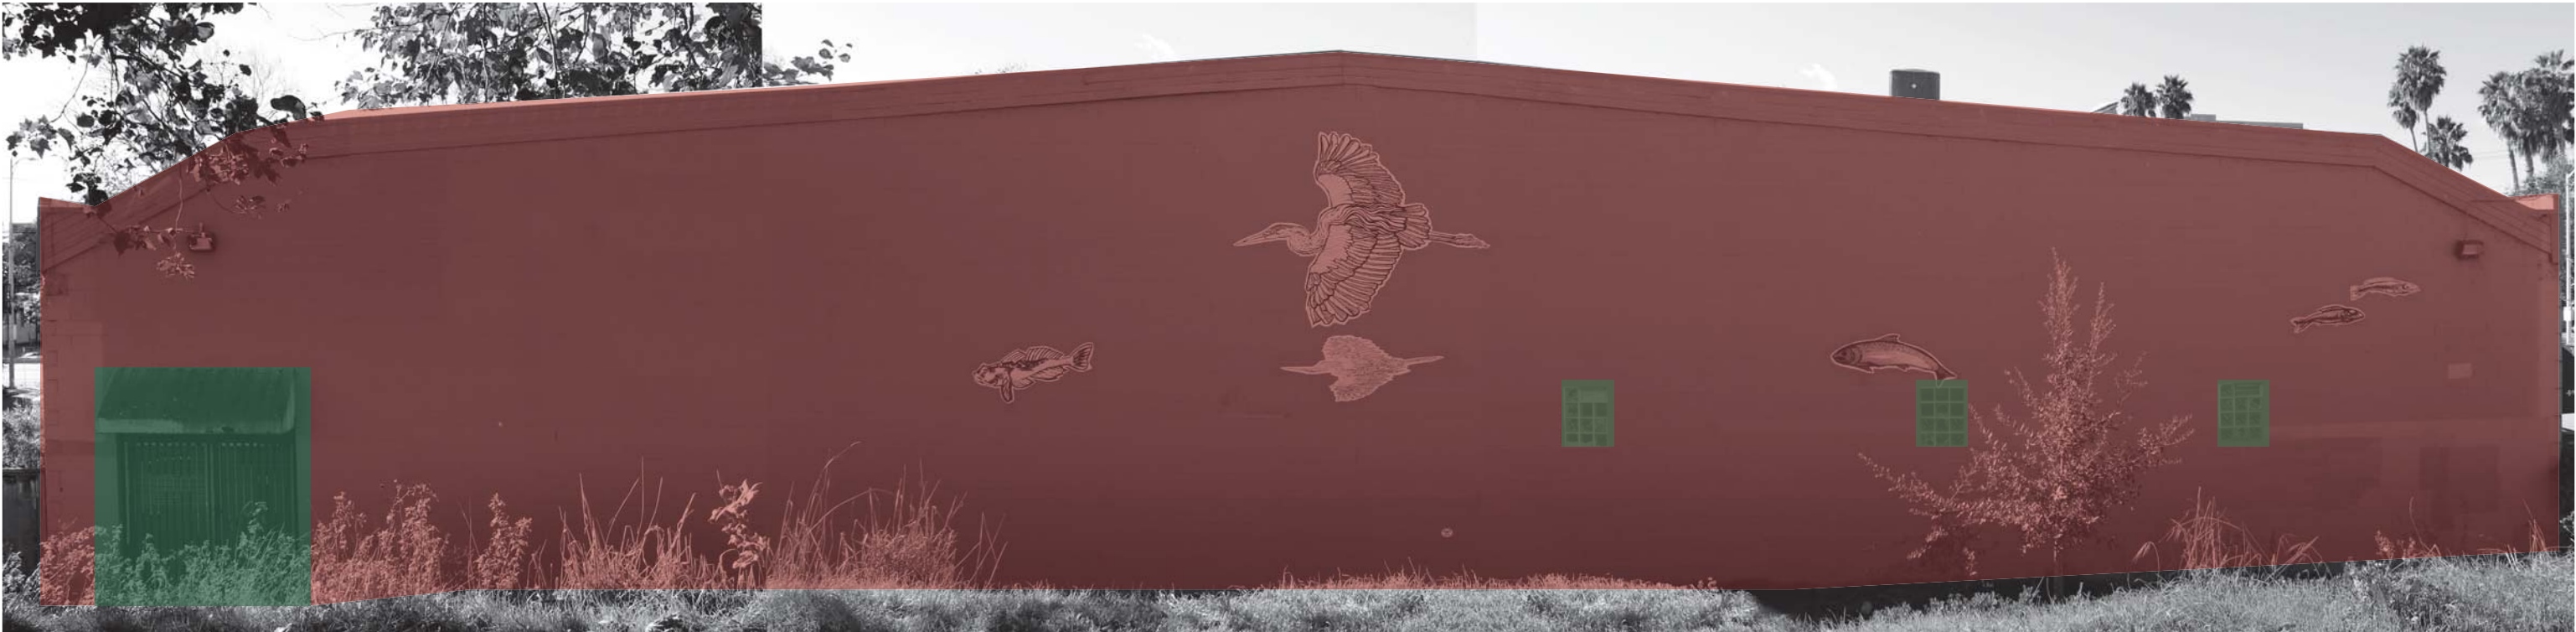
Significance Diagram: 428 Front Street-East Facade

- The rear (east) facade retains its original massing and roofline that corresponds to the building's framing.
- Glass block windows do not appear original and are non-contributing features.
- Door opening at southeast corner may be an original feature but does not contribute to building's character.

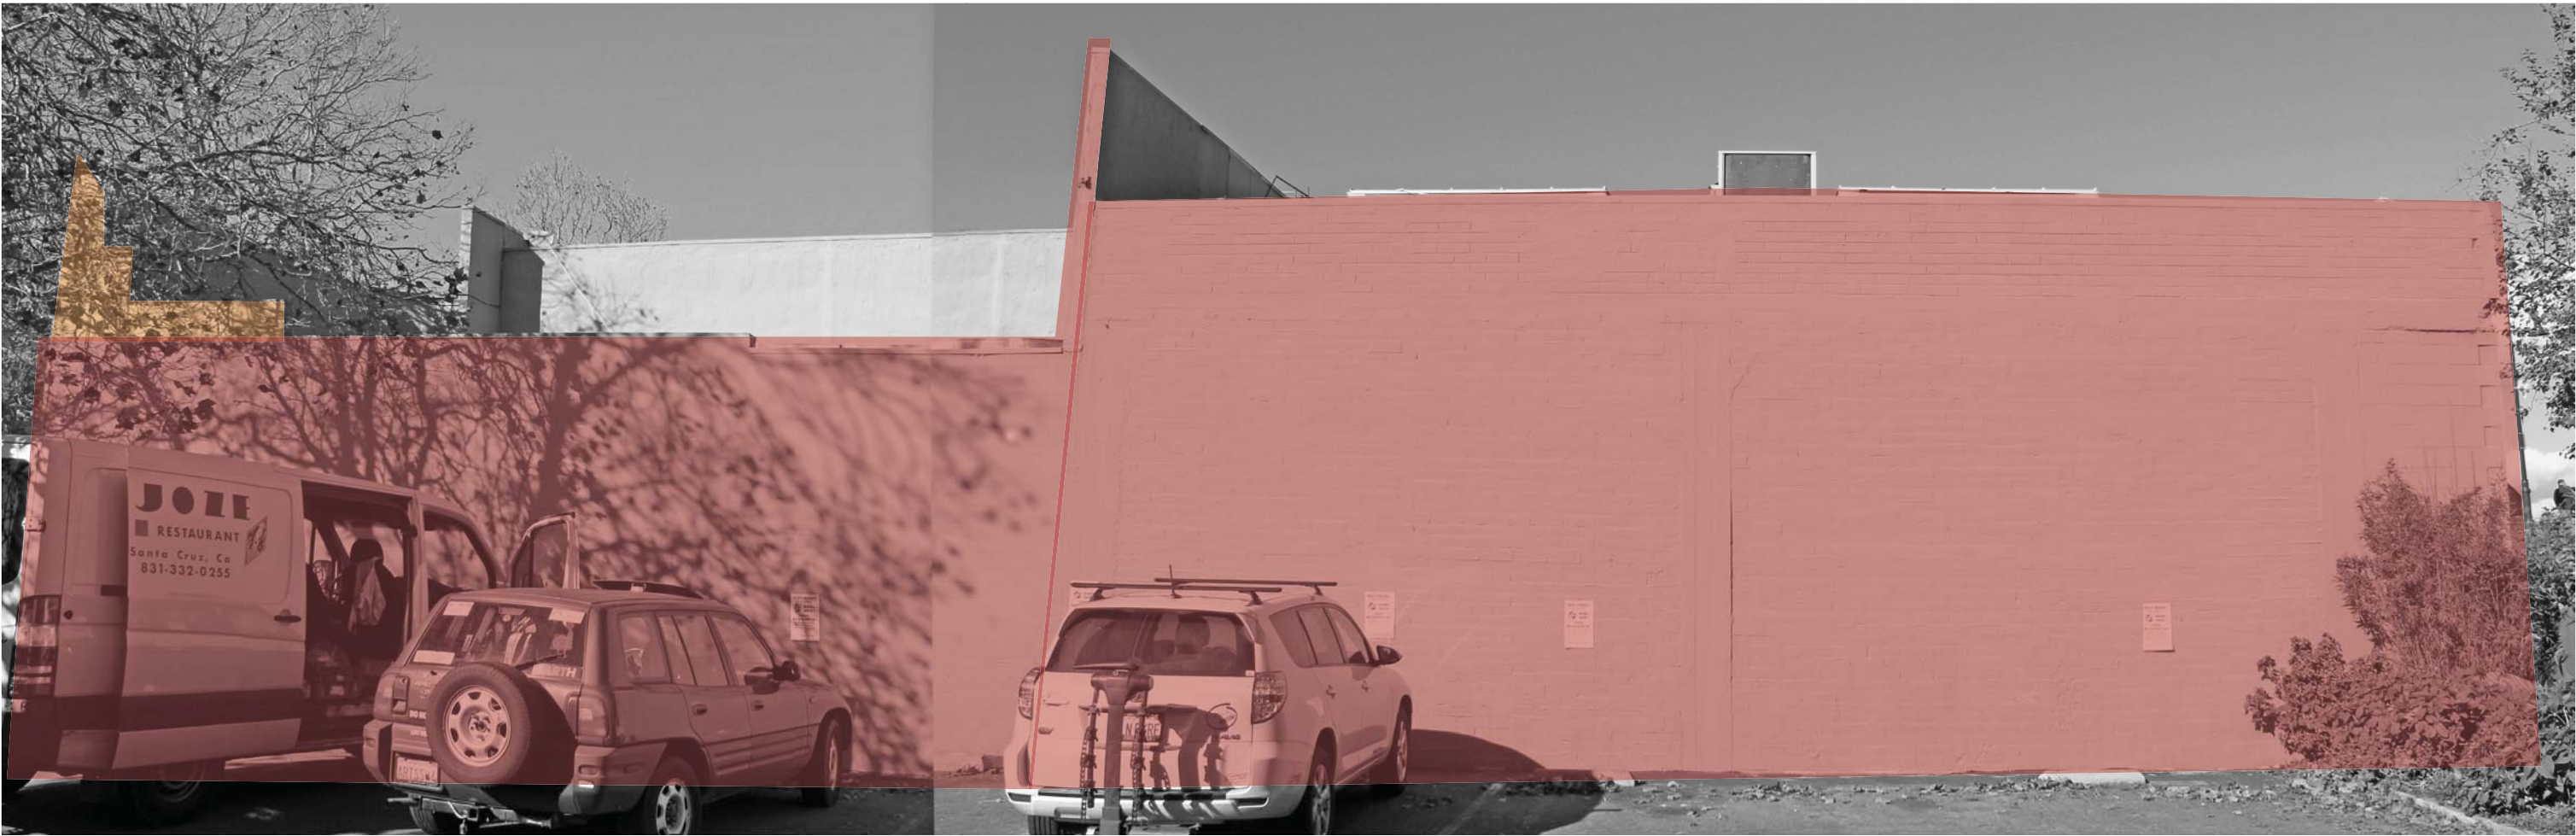
Significance Diagram: 428 Front Street-South Facade

- The south facade appears to have undergone little alteration.
- Meeting of building's main T-shaped and small square volumes are visible at this facade.
