State of California — The Resources Agency  
DEPARTMENT OF PARKS AND RECREATION  
**PRIMARY RECORD**

\*Resource Name or #: (assigned by recorder) 113 – 115 Knight Street

c. Address: 113 – 115 Knight St.

## B10. Significance: Significance Statement

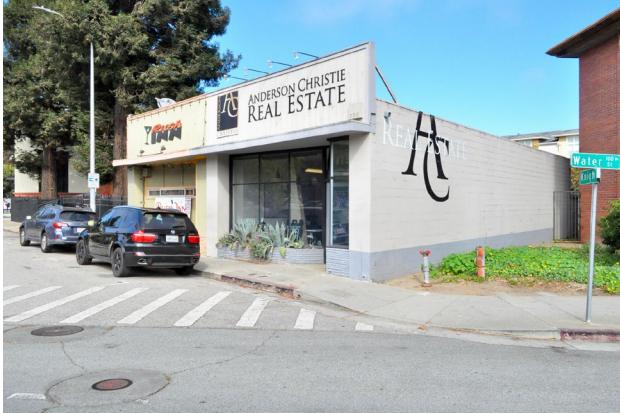
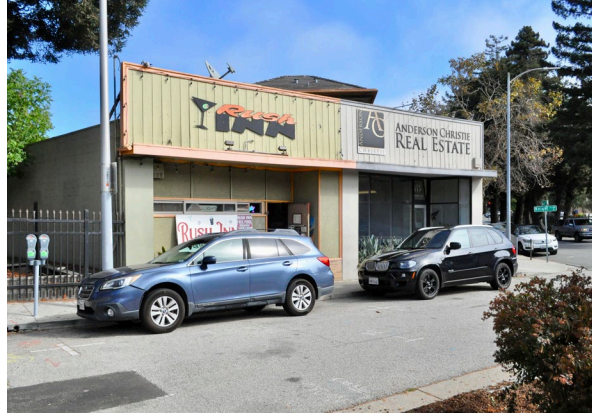
**Figures 1 and 2.** Left image shows the front (south) and right side (east) elevations. Right image shows the front and left side (west) elevations.

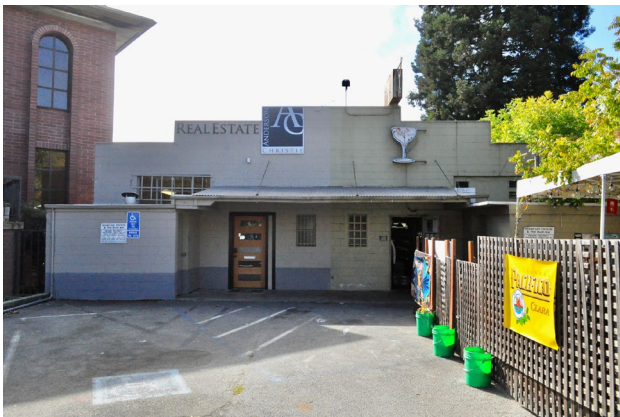
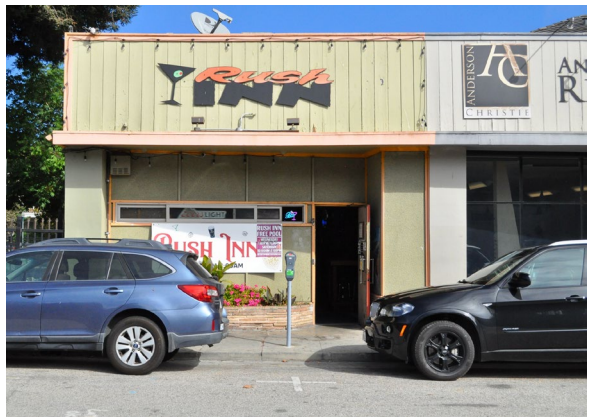
**Figures 3 and 4.** Left image shows the rear (north) elevation. Right image details the west storefront, showing the fenestration and entrance modifications.

2. **Design:** *the combination of elements that create the form, plan, space, structure, and style of a property.* The alterations to the storefront at 113 Knight Street have substantially modified the fenestration pattern, entrance and ornamentation of the original building, causing a considerable loss of integrity of design.

4. **Materials:** *the physical elements that were combined or deposited during a particular period of time and in a particular pattern or configuration to form a historic property.* The storefront, cladding and fenestration modifications to 113 Knight St. have compromised the integrity of materials from the original design of the building.

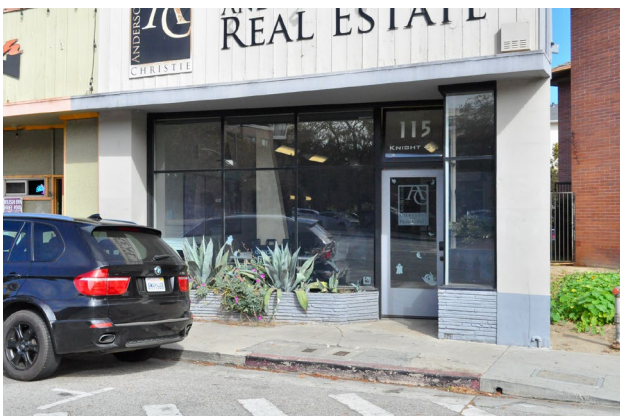
**Figure 5.** Detail of the east storefront.
