2025 Santa Cruz Wharf End Interim Repair Project Communications Team Update

Jan. 24, 2026 through Feb.10, 2026

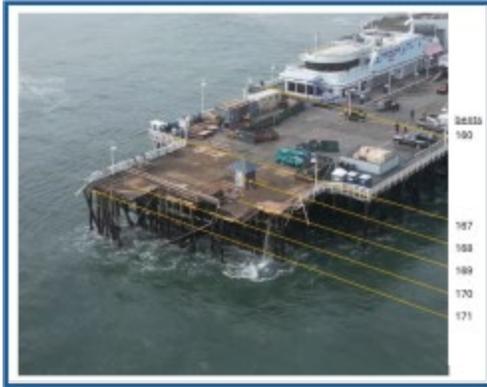
Bents 167-171 Post Collapse

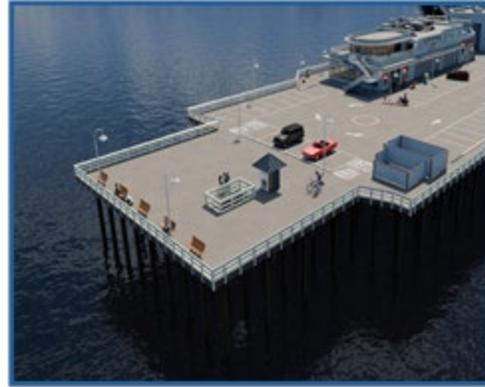
Bents 167-170 End Interim Repair

- 18 total piles driven.
- Rebuild of Bent 170 underway.
- Batter pile driven.
- Engineering inspections of completed and anticipated work conducted.

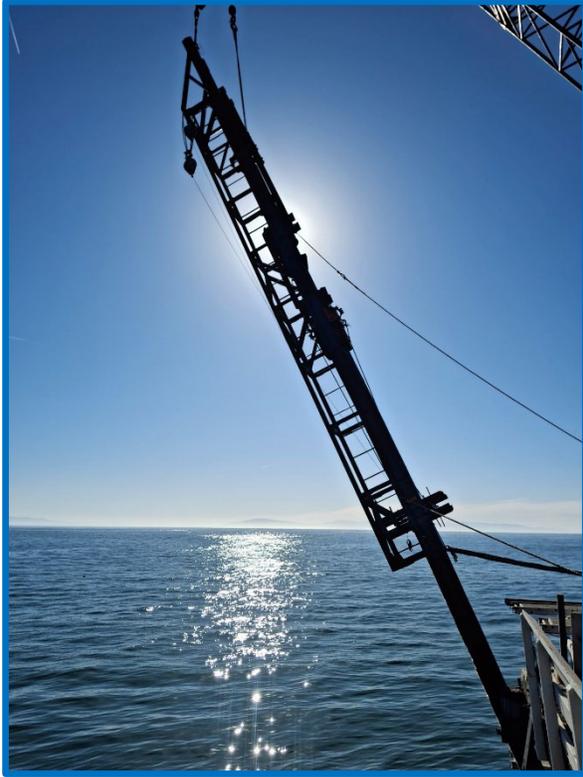
Batter pile poised for driving

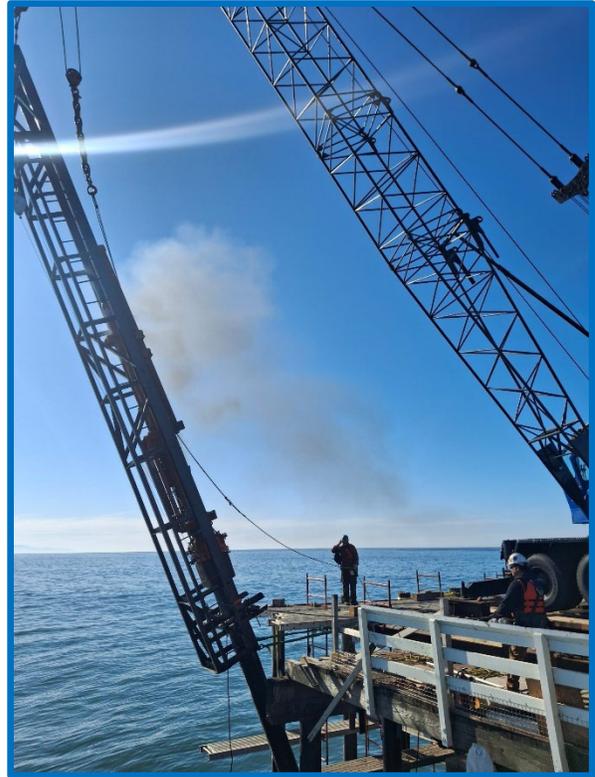
First strike of the pile driver hammer

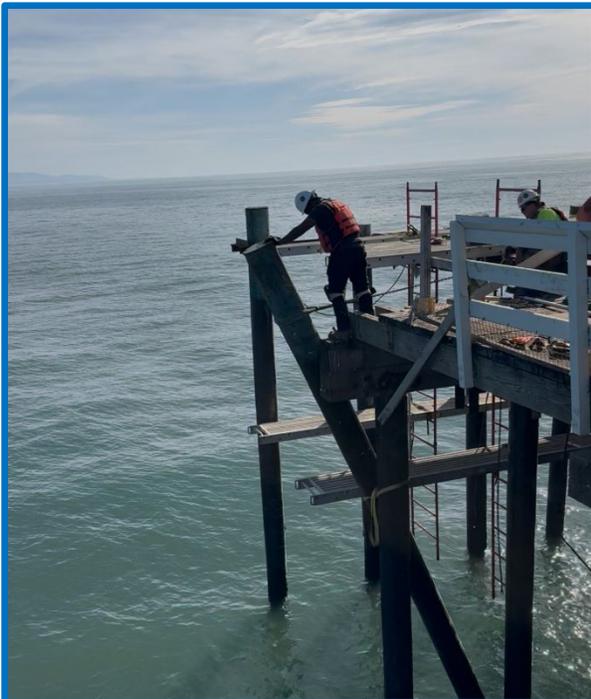
Batter pile in place ready to bolt to plumb pile

Batter piles are driven into the seafloor at a 45 degree angle, and act as a brace against sideways movement of the Wharf caused by wind and waves.

Plumb piles are driven vertically and support the weight of the Wharf structure and buildings.

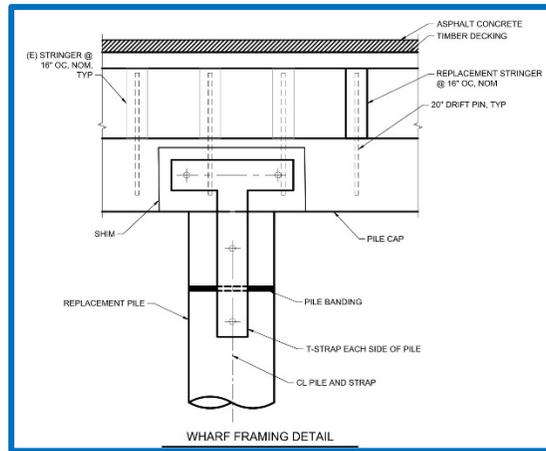
Wharf framing detail
