## TECHNICAL MEMORANDUM

**FROM:** Jeff Hagar  
HAGAR ENVIRONMENTAL SCIENCE

**DATE:** January 15, 2010

**PROJECT:** City of Santa Cruz Habitat Conservation Plan, Lagoon Fish Population Sampling

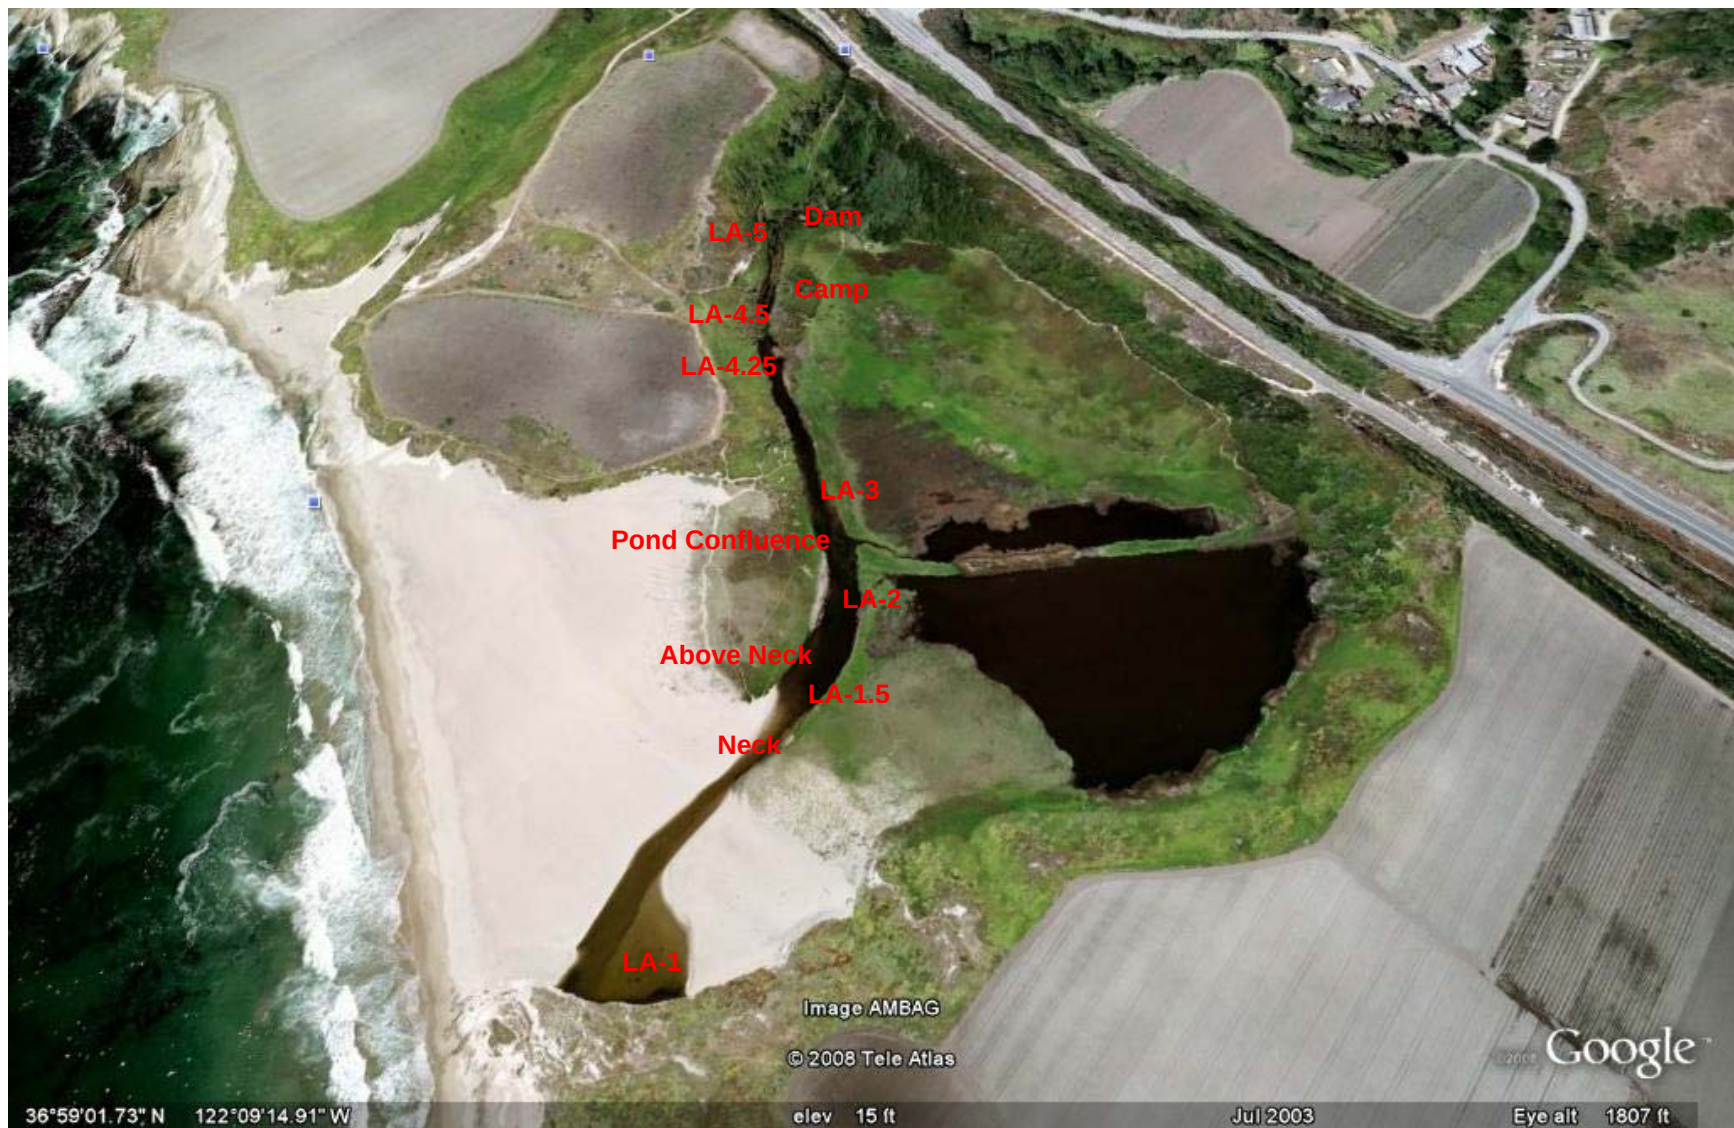
Laguna Creek Lagoon sampling sites.

Note: See Figures for sample site locations.
